## General Information

<b>Make</b>	Toyota	<b>Model</b>	Vios
<b>YOM</b>	2024	<b>Odo Meter Reading</b>	58,656
<b>Registration No.</b>	NIO4823	<b>Chassis No.</b>	PA1B18F36P4235581
<b>CC</b>	1.3	<b>Transmission</b>	CVT
<b>Fuel Type</b>	Gas	<b>Type of Body</b>	Sedan
<b>Colour</b>	Silver

## Body / Panel Condition

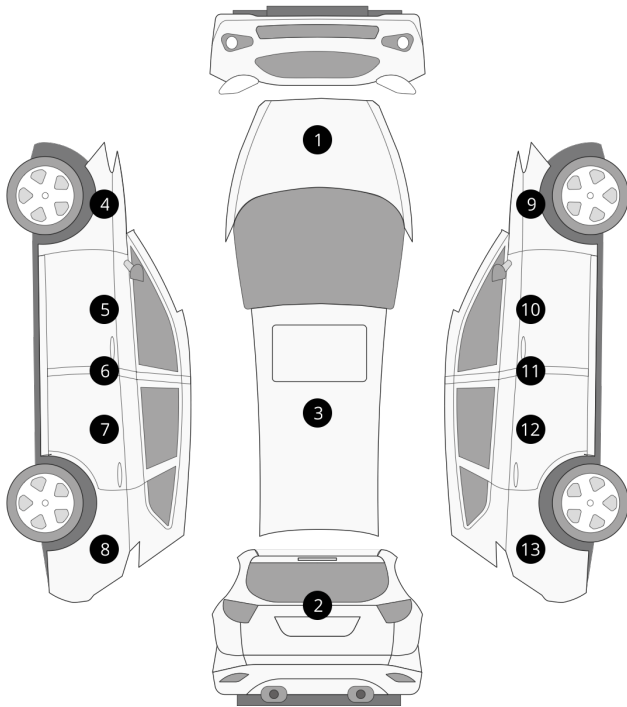
#	Area	Thickness(um)			
		Average	Value1	Value2	Value3/4
1	Bonnet	132.0	129	136	131
2	Boot Lid	119.0	111	117	129
3	Roof	107.7	106	111	106/108
4	Left Front Fender	103.3	104	102	104
5	Left Front Door	113.3	107	106	127
6	Center Panel Left				
7	Left Rear Door	164.3	154	170	169
8	Left Back Panel	171.0	190	167	156
9	Right Front Fender	209.6	161	256	212
10	Right Front Door	117.6	129	112	112
11	Center Panel Right				
12	Right Rear Door	111.3	105	105	124
13	Right Back Panel	115.6	123	114	110

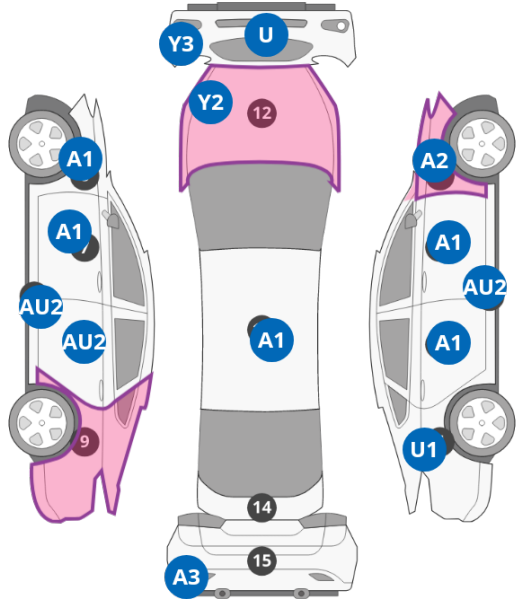
<p><b>A</b> : Scratch <b>AU</b> : Scratch &amp; Dent <b>B</b> : Modified <b>C</b> : Corrosion <b>G</b> : Stone chip <b>P</b> : Faded <b>S</b> : Rust <b>SC</b> : Rust &amp; Corrosion <b>U</b> : Dent <b>X</b> : Defective <b>Y</b> : Crack, Gap</p>
<p><b>Remarks</b> (L) Front Floor Mat - Worked - Small / (L) Front Trim - Worked - Small / (R) Front Trim - Worked - Small / Rear Seat - Grime - Small</p>	<p><b>Remarks</b> (R) Front Fender - Repair Traces - Yes / (L) Rear Fender - Repair Traces - Yes / Rear Bumper, Lamps, Panels - Scratch - Medium / (L) Rear Fender, Molding - Repair mark - Yes / (R) Front Fender, Molding - Repair mark - Yes / (L) Rear Door, Molding - Scratch &amp; Dent - Small / (L) Front Door, Molding - Scratch - Minimal / (L) Front Fender, Molding - Scratch - Minimal / (R) Step, In-panel, Side Spoiler - Scratch &amp; Dent - Small / (L) Step, In-panel, Side Spoiler - Scratch &amp; Dent - Small / (R) Front Door, Molding - Scratch - Minimal / (R) Rear Door, Molding - Scratch - Minimal / (R) Front Fender, Molding - Scratch - Small / (R) Rear Fender, Molding - Dent - Minimal / Bonnet, Headlight - Repair mark - Yes / Roof - Scratch - Minimal / Member (Bolted) - Dent - Yes / Front Bumper, Grille, Lamps - Crack, Gap - Medium / Bonnet, Headlight - Crack, Gap - Small</p>
