General Information

Date & Time: 19, Aug, 2025 09:51

Make	Toyota	Model	Veloz
YOM	2024	Odo Meter Reading	66,978
Registration No.	NIR8091	Chassis No.	MHFAB1BY2P3068420
CC	1.5	Transmission	CVT
Fuel Type	Gas	Type of Body	SUV
Colour	Silver

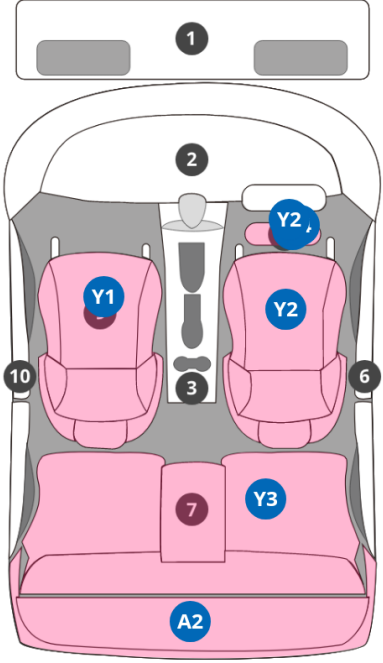
<p>a : Cut, Fray d : Loose, Deformed k : Animal Hair s : Smell t : Cigarette Burns x : Defective y : Stain</p>

<p>A : Scratch AU : Scratch & Dent B : Modified C : Corrosion G : Stone chip P : Faded S : Rust SC : Rust & Corrosion U : Dent X : Defective Y : Crack, Gap</p>
<p>Remarks Trunk Room - Worn, Scratch, Cut, Crack - Small / Rear Seat - Grime - Medium / Mat Other - Grime - Medium / (R) Front Floor Mat - Grime - Large / (R) Front Seat - Grime - Small / (L) Front Seat - Grime - Minimal / (L) Front Floor Mat - Grime - Small</p>	<p>Remarks (L) Front Fender - Repair Traces - Yes / Roof - Dent - Medium / Rear Bumper, Lamps, Panels - Scratch - Medium / Trunk Hood, Rear Gate - Scratch - Medium / (L) Mirror - Scratch - Minimal / (L) Front Fender, Molding - Repair mark - Yes / (L) Front Fender, Molding - Scratch - Minimal / Front Bumper, Grille, Lamps - Scratch - Minimal / (R) Front Door, Molding - Scratch - Minimal / Bonnet, Headlight - Scratch - Minimal / (L) Front Door, Molding - Scratch - Minimal / (L) Rear Fender, Molding - Scratch - Small / (R) Rear Door, Molding - Dent - Minimal</p>
