## General Information

Date & Time: 18, Aug, 2025 16:14

<b>Make</b>	Toyota	<b>Model</b>	Avanza
<b>YOM</b>	2024	<b>Odo Meter Reading</b>	18,796
<b>Registration No.</b>	DBO9497	<b>Chassis No.</b>	MHFAA1BY4R0027262
<b>CC</b>	1.3	<b>Transmission</b>	CVT
<b>Fuel Type</b>	Gas	<b>Type of Body</b>	MPV
<b>Colour</b>	Green

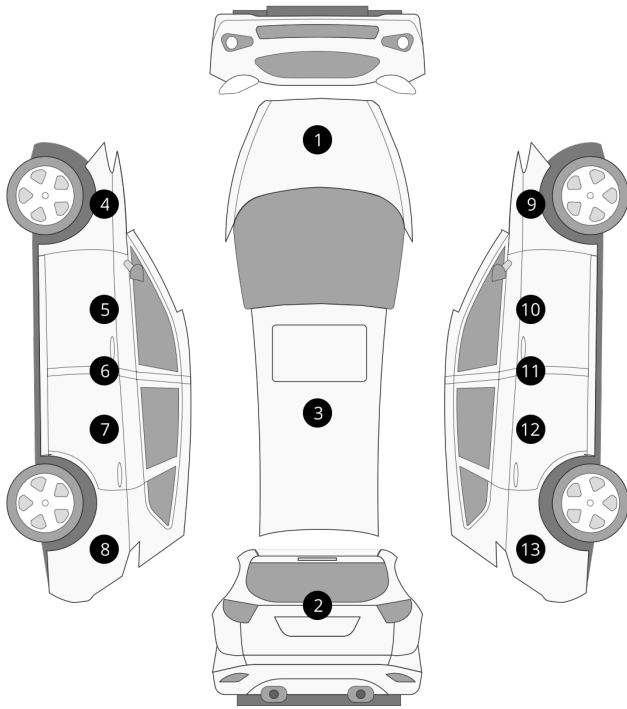
#	Area	Thickness(um)			
		Average	Value1	Value2	Value3/4
1	Bonnet	112.6	105	118	115
2	Boot Lid	104.1	107	111	94
3	Roof	128.7	148	133	111/123
4	Left Front Fender	113.6	128	109	104
5	Left Front Door	118.0	108	116	130
6	Center Panel Left				
7	Left Rear Door	121.3	132	112	120
8	Left Back Panel	125.3	134	116	126
9	Right Front Fender	114.6	117	114	113
10	Right Front Door	123.3	132	120	118
11	Center Panel Right				
12	Right Rear Door	129.6	149	112	128
13	Right Back Panel	124.6	142	107	125

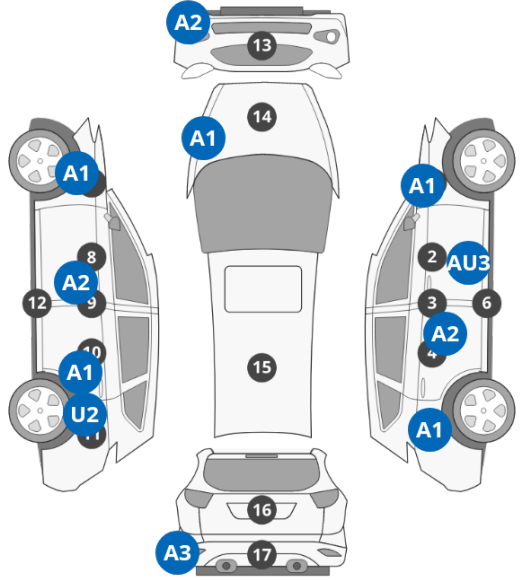
<p><b>A</b> : Scratch <b>AU</b> : Scratch &amp; Dent <b>B</b> : Modified <b>C</b> : Corrosion <b>G</b> : Stone chip <b>P</b> : Faded <b>S</b> : Rust <b>SC</b> : Rust &amp; Corrosion <b>U</b> : Dent <b>X</b> : Defective <b>Y</b> : Crack, Gap</p>
<p><b>Remarks</b> Rear Seat - Grime - Large / Overall Interior - Smell - Yes / (R) Front Seat - Grime - Medium / (L) Front Seat - Worn - Yes / Console, Switchs, Vents - Traces of Adhesive Tape - Yes / (L) Front Floor Mat - Grime - Small / Ceiling - Grime - Small</p>	<p><b>Remarks</b> (R) Front Fender, Molding - Scratch - Minimal / (R) Front Door, Molding - Scratch &amp; Dent - Medium / (R) Rear Door, Molding - Scratch - Small / (R) Rear Fender, Molding - Scratch - Minimal / Rear Bumper, Lamps, Panels - Scratch - Medium / (L) Rear Fender, Molding - Dent - Small / (L) Rear Door, Molding - Scratch - Minimal / (L) Front Door, Molding - Scratch - Small / (L) Front Fender, Molding - Scratch - Minimal / Front Bumper, Grille, Lamps - Scratch - Small / Bonnet, Headlight - Scratch - Minimal</p>
