## General Information

<b>Make</b>	Toyota	<b>Model</b>	Hiace
<b>YOM</b>	2023	<b>Odo Meter Reading</b>	201,629
<b>Registration No.</b>	EAG1221	<b>Chassis No.</b>	JTFNAFAP9N8026738
<b>CC</b>	2.8	<b>Transmission</b>	M/T
<b>Fuel Type</b>	Diesel	<b>Type of Body</b>	Van
<b>Colour</b>	Silver

## Body / Panel Condition

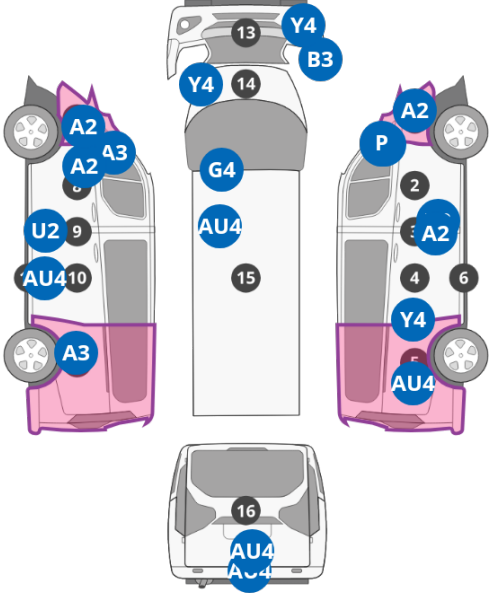
<p><b>A</b> : Scratch <b>AU</b> : Scratch &amp; Dent <b>B</b> : Modified <b>C</b> : Corrosion <b>G</b> : Stone chip <b>P</b> : Faded <b>S</b> : Rust <b>SC</b> : Rust &amp; Corrosion <b>U</b> : Dent <b>X</b> : Defective <b>Y</b> : Crack, Gap</p>
<p><b>Remarks</b> Overall Interior - Worn as per age - Yes / Overall Interior - Smell - Yes / (L) Front Seat - Grime - Medium / (R) Front Seat - Grime - Medium / Dashboard - Traces of Adhesive Tape - Yes / Sunvisor, Sunglass Holder - Grime - Medium / Rear Seat - Grime - Medium / Ceiling - Grime - Medium / (L) Rear Trim - Cut, Crack - Medium / (R) Rear Trim - Cut, Crack - Medium / (R) Front Floor Mat - Grime - Medium / (L) Front Floor Mat - Worked - Large / Console, Switches, Vents - Traces of Adhesive Tape - Yes</p>	<p><b>Remarks</b> (R) Front Door - Repair Traces - Yes / (R) Step - Repair Traces - Yes / (R) Front Fender - Repair Traces - Yes / Bonnet - Repair Traces - Yes / (L) Front Fender - Repair Traces - Yes / (L) Front Door - Repair Traces - Yes / (L) Rear Fender - Repair Traces - Yes / Trunk Hood, Rear Gate - Repair Traces - Yes / (R) Rear Fender - Repair Traces - Yes / (R) Rear Door - Repair Traces - Yes / (R) Center Panel - Repair Traces - Yes / Roof - Repair Traces - Yes / Front Bumper, Grille, Lamps - Modified - Medium / Overall Exterior - Re-Paint Uneven - Yes / (R) Front Fender, Molding - Scratch - Small / (R) Mirror - Stuck - Yes / (R) Mirror - Scratch - Small / (R) Front Door, Molding - Crack, Gap - Medium / (R) Center Panel - Scratch - Small / (R) Rear Door, Molding - Crack, Gap - Large / (R) Rear Fender, Molding - Scratch &amp; Dent - Large / Rear Bumper, Lamps, Panels - Scratch &amp; Dent - Large / Trunk Hood, Rear Gate - Scratch &amp; Dent - Large / (L) Rear Fender, Molding - Scratch - Medium / (L) Rear Door, Molding - Scratch &amp; Dent - Large / (L) Center Panel - Dent - Small / (L) Mirror - Scratch - Medium / (L) Front Door, Molding - Scratch - Small / (L) Front Fender, Molding - Scratch - Small / Front Bumper, Grille, Lamps - Crack, Gap - Large / Bonnet, Headlight - Crack, Gap - Large / Front Windshield - Scratch, Stone chip - Large / Roof - Scratch &amp; Dent - Large / (R) Mirror - Faded(Color, Gloss) - Yes / (R) Front Wheel, Cover - Cap Missing - Yes / (R) Rear Wheel, Cover - Cap Missing - Yes / (L) Front Wheel, Cover - Cap Missing - Yes / (L) Rear Wheel, Cover - Cap Missing - Yes</p>
