General Information

Date & Time: 18, Aug, 2025 10:41

Make	Toyota	Model	Vios
YOM	2021	Odo Meter Reading	103,095
Registration No.	NFI3178	Chassis No.	PA1B18F38M4159213
CC	1.3	Transmission	CVT
Fuel Type	Gas	Type of Body	Sedan
Colour	Red Mica Metallic

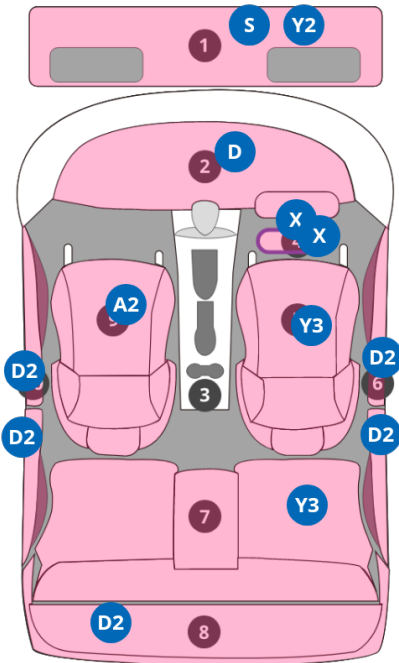
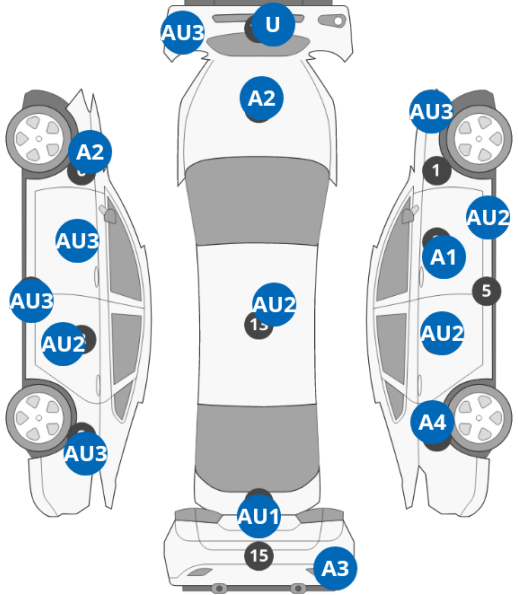
Interior Evaluation :	C	Exterior Evaluation :	E

<p>a : Cut, Fray d : Loose, Deformed k : Animal Hair s : Smell t : Cigarette Burns x : Defective y : Stain</p>		<p>A : Scratch AU : Scratch & Dent B : Modified C : Corrosion G : Stone chip P : Faded S : Rust SC : Rust & Corrosion U : Dent X : Defective Y : Crack, Gap</p>	
<p>Remarks Rear Seat - Grime - Medium / (R) Front Seat - Grime - Medium / (L) Front Seat - Cut, Crack - Small / (L) Front Floor Mat - Missing - Yes / (R) Front Floor Mat - Missing - Yes / Mat Other - Missing - Yes / Overall Interior - Smell - Yes / Ceiling - Grime - Small / Dashboard - Traces of Adhesive Tape - Yes / Switchs - Stuck - Yes / (L) Front Trim - Worked - Small / (R) Front Trim - Worked - Small / (L) Rear Trim - Worked - Small / (R) Rear Trim - Worked - Small / Trunk Room - Loose, Deformed - Small</p>		<p>Remarks (R) Step, In-panel, Side Spoiler - Scratch & Dent - Small / (R) Rear Fender, Molding - Scratch - Large / (R) Rear Door, Molding - Scratch & Dent - Small / (R) Front Door, Molding - Scratch - Minimal / Rear Bumper, Lamps, Panels - Scratch - Medium / Trunk Hood, Rear Gate - Scratch & Dent - Minimal / (L) Rear Fender, Molding - Scratch & Dent - Medium / (L) Step, In-panel, Side Spoiler - Scratch & Dent - Medium / (L) Rear Door, Molding - Scratch & Dent - Small / (L) Front Door, Molding - Scratch & Dent - Medium / (L) Front Fender, Molding - Scratch - Small / Member (Bolted) - Dent - Yes / Front Bumper, Grille, Lamps - Scratch & Dent - Medium / Bonnet, Headlight - Scratch - Small / (R) Front Fender, Molding - Scratch & Dent - Medium / Roof - Scratch & Dent - Small</p>
