## General Information

Date & Time: 18, Aug, 2025 17:17

<b>Make</b>	Toyota	<b>Model</b>	Veloz
<b>YOM</b>	2024	<b>Odo Meter Reading</b>	16,563
<b>Registration No.</b>	NIU8315	<b>Chassis No.</b>	MHFAB1BY8R3085046
<b>CC</b>	1.5	<b>Transmission</b>	CVT
<b>Fuel Type</b>	Gas	<b>Type of Body</b>	SUV
<b>Colour</b>	Black

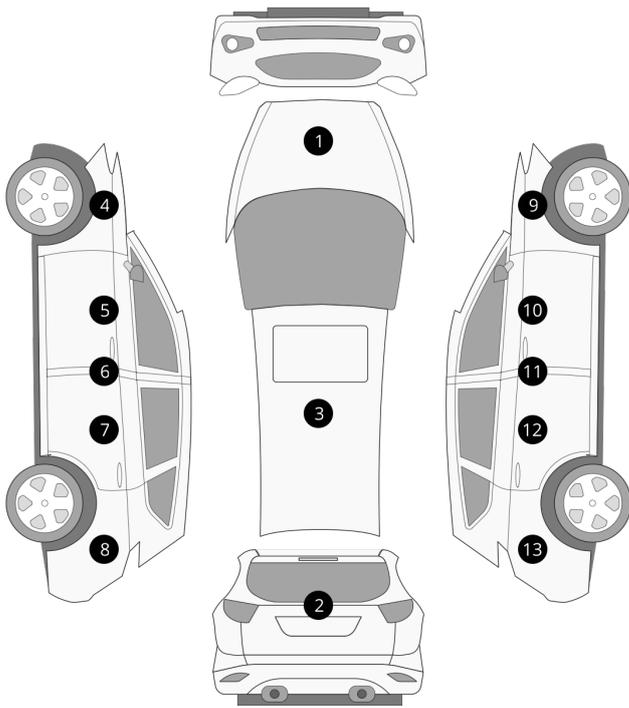
#	Area	Thickness(um)			
		Average	Value1	Value2	Value3/4
1	Bonnet	120.6	116	131	115
2	Boot Lid	108.3	111	115	99
3	Roof	126.0	128	148	113/115
4	Left Front Fender	111.6	114	112	109
5	Left Front Door	121.6	115	121	129
6	Center Panel Left				
7	Left Rear Door	119.6	125	115	119
8	Left Back Panel	110.5	133	85	114
9	Right Front Fender	114.6	110	118	116
10	Right Front Door	111.3	115	109	110
11	Center Panel Right				
12	Right Rear Door	113.0	115	108	116
13	Right Back Panel	129.3	113	129	146

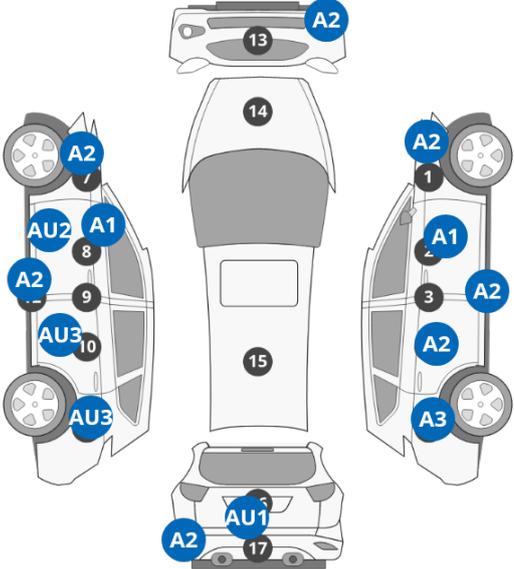
<p><b>A</b> : Scratch <b>AU</b> : Scratch &amp; Dent <b>B</b> : Modified <b>C</b> : Corrosion <b>G</b> : Stone chip <b>P</b> : Faded <b>S</b> : Rust <b>SC</b> : Rust &amp; Corrosion <b>U</b> : Dent <b>X</b> : Defective <b>Y</b> : Crack, Gap</p>
<p><b>Remarks</b> (R) Front Seat - Grime - Minimal / (L) Front Floor Mat - Worked - Small</p>	<p><b>Remarks</b> (R) Rear Door, Molding - Scratch - Small / (R) Front Door, Molding - Scratch - Minimal / (R) Rear Fender, Molding - Scratch - Medium / Trunk Hood, Rear Gate - Scratch &amp; Dent - Minimal / Rear Bumper, Lamps, Panels - Scratch - Small / (L) Rear Fender, Molding - Scratch &amp; Dent - Medium / (L) Rear Door, Molding - Scratch &amp; Dent - Medium / (L) Front Door, Molding - Scratch &amp; Dent - Small / (L) Front Fender, Molding - Scratch - Small / (L) Step, In-panel, Side Spoiler - Scratch - Small / (R) Step, In-panel, Side Spoiler - Scratch - Small / (L) Mirror - Scratch - Minimal / (R) Front Fender, Molding - Scratch - Small / Front Bumper, Grille, Lamps - Scratch - Small</p>

<p><b>Inspector Notes</b></p>
<p>With LTO plate and warranty booklet and Sparetire and Jack, Incomplete Tools. Scratch headlight and tail light.</p>
