## General Information

<b>Make</b>	Nissan	<b>Model</b>	Almera
<b>YOM</b>	2021	<b>Odo Meter Reading</b>	20,117
<b>Registration No.</b>	LAI1278	<b>Chassis No.</b>	BDUALBAN17C59609
<b>CC</b>	1.5	<b>Transmission</b>	A/T
<b>Fuel Type</b>	Gas	<b>Type of Body</b>	Sedan
<b>Colour</b>	Blue

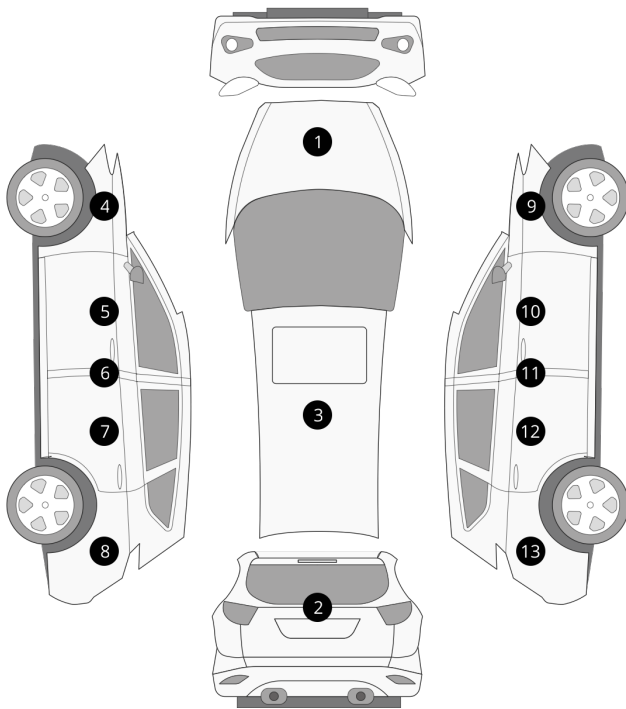
## Body / Panel Condition

#	Area	Thickness(um)			
		Average	Value1	Value2	Value3/4
1	Bonnet	<b>134.3</b>	132	137	134
2	Boot Lid	<b>98.2</b>	90	85	120
3	Roof	<b>132.5</b>	129	131	131/139
4	Left Front Fender	<b>131.3</b>	108	140	146
5	Left Front Door	<b>108.5</b>	96	102	128
6	Center Panel Left				
7	Left Rear Door	<b>122.6</b>	126	108	134
8	Left Back Panel	<b>151.3</b>	192	134	128
9	Right Front Fender	<b>155.3</b>	156	156	154
10	Right Front Door	<b>173.3</b>	179	168	173
11	Center Panel Right				
12	Right Rear Door	<b>140.0</b>	119	108	193
13	Right Back Panel	<b>133.6</b>	125	122	154

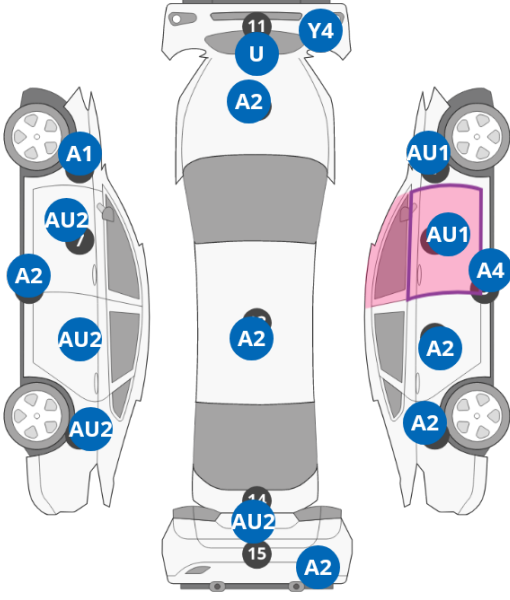
<p><b>A</b> : Scratch <b>AU</b> : Scratch &amp; Dent <b>B</b> : Modified <b>C</b> : Corrosion <b>G</b> : Stone chip <b>P</b> : Faded <b>S</b> : Rust <b>SC</b> : Rust &amp; Corrosion <b>U</b> : Dent <b>X</b> : Defective <b>Y</b> : Crack, Gap</p>
<p><b>Remarks</b> (L) Front Floor Mat - Worked - Small / (R) Front Floor Mat - Worked - Small / Ceiling - Grime - Small / (R) Front Seat - Grime - Small / (L) Front Seat - Grime - Small / Rear Seat - Grime - Small</p>	<p><b>Remarks</b> (R) Front Door - Repair Traces - Yes / (L) Rear Door, Molding - Scratch &amp; Dent - Small / (L) Front Door, Molding - Scratch &amp; Dent - Small / (L) Rear Fender, Molding - Scratch &amp; Dent - Small / (L) Front Fender, Molding - Scratch - Minimal / (L) Step, In-panel, Side Spoiler - Scratch - Small / Front Bumper, Grille, Lamps - Crack, Gap - Large / Member (Bolted) - Dent - Yes / (R) Front Door, Molding - Repair mark - Yes / (R) Front Fender, Molding - Scratch &amp; Dent - Minimal / (R) Front Door, Molding - Scratch &amp; Dent - Minimal / (R) Rear Door, Molding - Scratch - Small / Bonnet, Headlight - Scratch - Small / (R) Step, In-panel, Side Spoiler - Scratch - Large / (R) Rear Fender, Molding - Scratch - Small / Rear Bumper, Lamps, Panels - Scratch - Small / Trunk Hood, Rear Gate - Scratch &amp; Dent - Small / Roof - Scratch - Small</p>
