## General Information

<b>Make</b>	Toyota	<b>Model</b>	Avanza
<b>YOM</b>	2022	<b>Odo Meter Reading</b>	46,303
<b>Registration No.</b>	CAX2927	<b>Chassis No.</b>	MHKM5EF2FMK029670
<b>CC</b>	1.3	<b>Transmission</b>	A/T
<b>Fuel Type</b>	Gas	<b>Type of Body</b>	Wagon
<b>Colour</b>	Black

## Body / Panel Condition

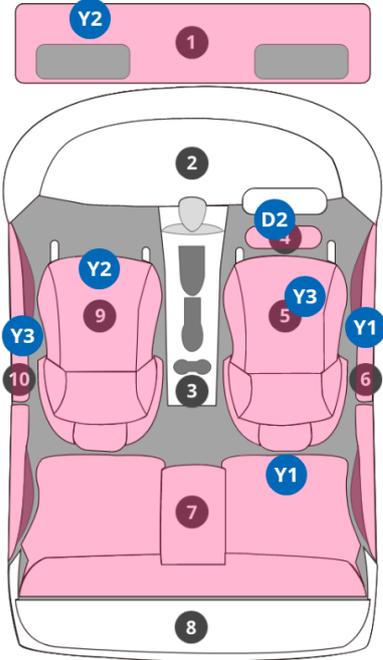
<b>Interior Evaluation :</b> <span style="float: right; color: red; font-weight: bold;">B</span>	<b>Exterior Evaluation :</b> <span style="float: right; color: red; font-weight: bold;">C</span>

<p><b>A</b> : Scratch <b>AU</b> : Scratch &amp; Dent <b>B</b> : Modified <b>C</b> : Corrosion <b>G</b> : Stone chip <b>P</b> : Faded <b>S</b> : Rust <b>SC</b> : Rust &amp; Corrosion <b>U</b> : Dent <b>X</b> : Defective <b>Y</b> : Crack, Gap</p>
<p><b>Remarks</b>          Mat Other - Worked - Small / Ceiling - Grime - Small / (L) Front Seat - Grime - Small / (R) Front Seat - Grime - Medium / (L) Front Trim - Grime - Medium / Rear Seat - Grime - Minimal / (R) Front Trim - Grime - Minimal</p>	<p><b>Remarks</b>          (R) Front Fender, Molding - Scratch - Small / (R) Mirror - Scratch - Small / (R) Front Door, Molding - Scratch - Minimal / (R) Rear Door, Molding - Scratch - Small / (R) Rear Fender, Molding - Scratch &amp; Dent - Minimal / Rear Bumper, Lamps, Panels - Scratch - Medium / Trunk Hood, Rear Gate - Scratch - Small / (L) Rear Fender, Molding - Scratch - Minimal / (L) Front Door, Molding - Scratch - Small / (L) Rear Door, Molding - Scratch - Small / (L) Mirror - Scratch - Small / (L) Front Fender, Molding - Scratch - Small / Front Bumper, Grille, Lamps - Scratch &amp; Dent - Medium / Bonnet, Headlight - Scratch - Minimal / Roof - Dent - Small</p>

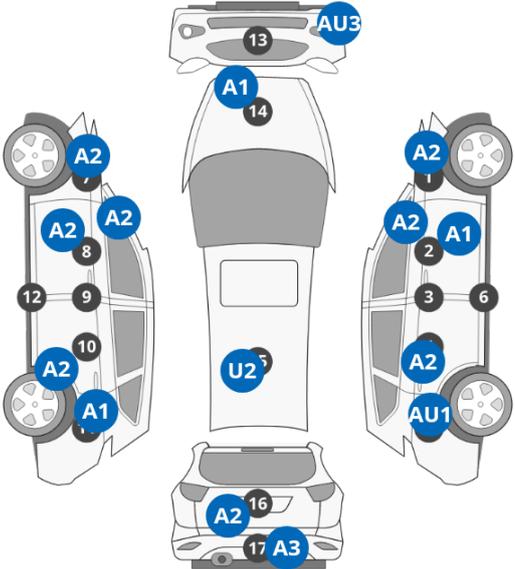
<p><b>Inspector Notes</b></p>
<p>no warranty booklet, no jack and tools, with spare tire, with LTO plate, scratches on headlight and tail light, brake lights issue</p>
