## General Information

<b>Make</b>	Toyota	<b>Model</b>	Vios
<b>YOM</b>	2024	<b>Mileage</b>	29,028
<b>Registration No.</b>	DBN5755	<b>Chassis No.</b>	PA1B18F33P4232198
<b>CC</b>	1.3	<b>Transmission</b>	CVT
<b>Fuel Type</b>	Gas	<b>Type of Body</b>	Sedan
<b>Colour</b>	Red

## Body / Panel Condition

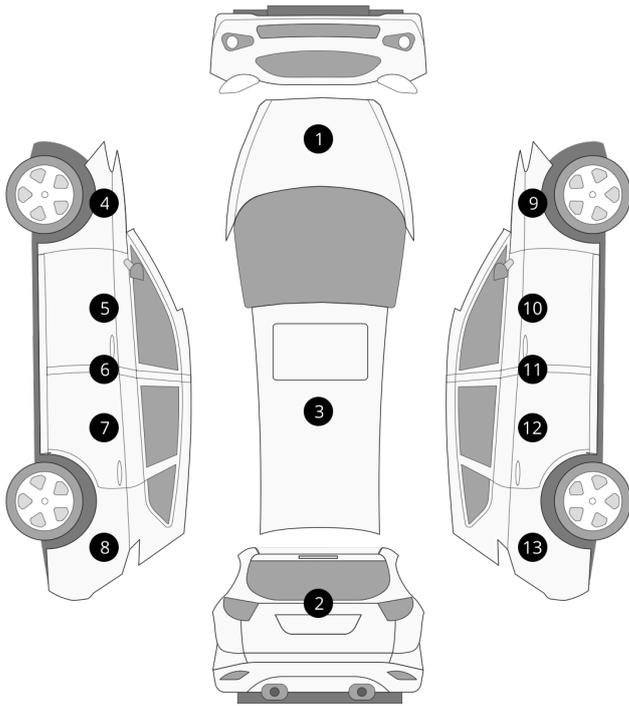
#	Area	Thickness(um)			
		Average	Value1	Value2	Value3/4
1	Bonnet	109.3	117	104	107
2	Boot Lid	109.0	108	107	112
3	Roof	106.0	100	100	110/114
4	Left Front Fender	100.3	102	102	97
5	Left Front Door	97.8	97	100	97
6	Center Panel Left				
7	Left Rear Door	100.3	102	98	101
8	Left Back Panel	112.3	116	113	108
9	Right Front Fender	99.6	100	102	97
10	Right Front Door	101.6	103	102	100
11	Center Panel Right				
12	Right Rear Door	97.4	96	97	99
13	Right Back Panel	104.4	97	100	116

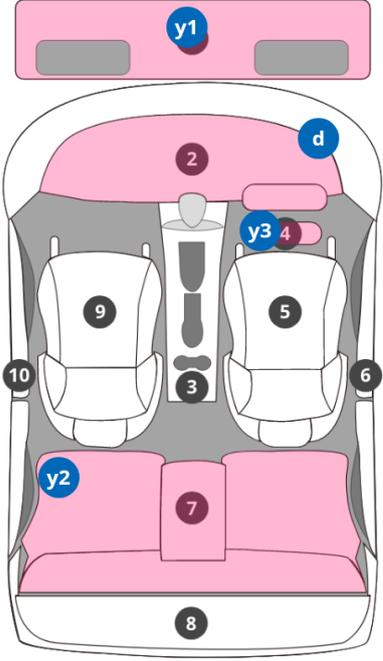
<b>Interior Evaluation :</b> <span style="float: right;"><b>B</b></span>	<b>Exterior Evaluation :</b> <span style="float: right;"><b>C</b></span>

<p><b>a</b> : Cut, Fray <b>d</b> : Loose, Deformed <b>k</b> : Animal Hair <b>s</b> : Smell <b>t</b> : Cigarette Burns <b>x</b> : Defective <b>y</b> : Stain</p>

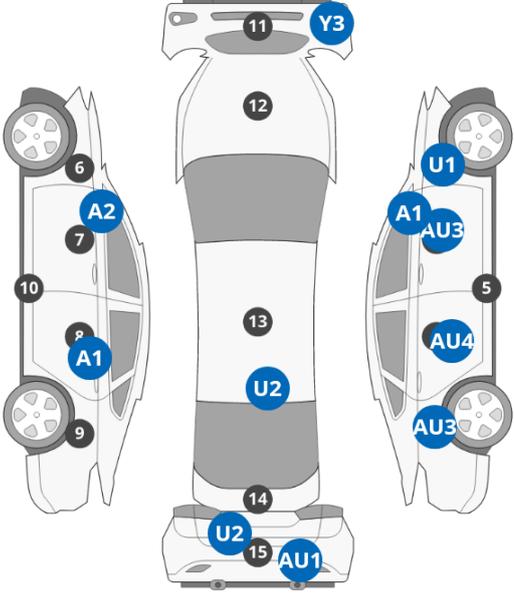
<p><b>A</b> : Scratch <b>AU</b> : Scratch &amp; Dent <b>B</b> : Modified <b>C</b> : Corrosion <b>G</b> : Stone chip <b>P</b> : Faded <b>S</b> : Rust <b>SC</b> : Rust &amp; Corrosion <b>U</b> : Dent <b>X</b> : Defective <b>Y</b> : Crack, Gap</p>
<p><b>Remarks</b> Ceiling - Grime - Minimal / Rear Seat - Grime - Small / (L) Front Floor Mat - Grime - Medium / Dashboard - Traces of Adhesive Tape - Yes</p>	<p><b>Remarks</b> Trunk Hood, Rear Gate - Dent - Small / (R) Rear Fender, Molding - Scratch &amp; Dent - Medium / (R) Rear Door, Molding - Scratch &amp; Dent - Large / (R) Front Door, Molding - Scratch &amp; Dent - Medium / (R) Front Fender, Molding - Dent - Minimal / (L) Mirror - Scratch - Small / Front Bumper, Grille, Lamps - Crack, Gap - Medium / Rear Bumper, Lamps, Panels - Scratch &amp; Dent - Minimal / (L) Rear Door, Molding - Scratch - Minimal / (R) Mirror - Scratch - Minimal / Roof - Dent - Small</p>

<p><b>Inspector Notes</b></p>
<p>swirlmarks and hairline scratches around the exterior. with tools and user manual. No warranty booklet.</p>
