## General Information

<b>Make</b>	Toyota	<b>Model</b>	Vios
<b>YOM</b>	2023	<b>Odo Meter Reading</b>	39,227
<b>Registration No.</b>	NHD7800	<b>Chassis No.</b>	PA1B18F38P4204137
<b>CC</b>	1.3	<b>Transmission</b>	CVT
<b>Fuel Type</b>	Gas	<b>Type of Body</b>	Sedan
<b>Colour</b>	Red

## Body / Panel Condition

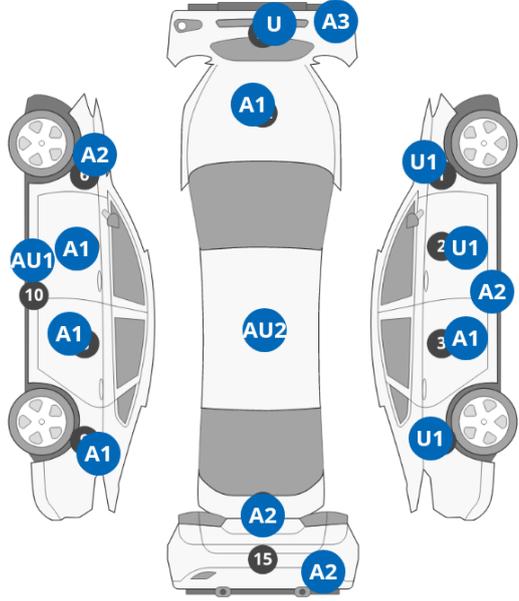
<p><b>A</b> : Scratch <b>AU</b> : Scratch &amp; Dent <b>B</b> : Modified <b>C</b> : Corrosion <b>G</b> : Stone chip <b>P</b> : Faded <b>S</b> : Rust <b>SC</b> : Rust &amp; Corrosion <b>U</b> : Dent <b>X</b> : Defective <b>Y</b> : Crack, Gap</p>
<p><b>Remarks</b> Overall Interior - Smell - Yes / Rear Seat - Grime - Small / (R) Front Seat - Grime - Small / (L) Front Floor Mat - Worked - Small / (L) Front Seat - Grime - Small / (L) Front Trim - Worked - Small / (R) Front Trim - Worked - Small / Dashboard - Traces of Adhesive Tape - Yes / Trunk Room - Loose, Deformed - Small</p>	<p><b>Remarks</b> (L) Rear Fender, Molding - Scratch - Minimal / (L) Rear Door, Molding - Scratch - Minimal / (L) Step, In-panel, Side Spoiler - Scratch &amp; Dent - Minimal / (L) Front Door, Molding - Scratch - Minimal / (L) Front Fender, Molding - Scratch - Small / Member (Bolted) - Dent - Yes / Trunk Hood, Rear Gate - Scratch - Small / (R) Rear Fender, Molding - Dent - Minimal / (R) Front Door, Molding - Dent - Minimal / (R) Rear Door, Molding - Scratch - Minimal / (R) Step, In-panel, Side Spoiler - Scratch - Small / (R) Front Fender, Molding - Dent - Minimal / Rear Bumper, Lamps, Panels - Scratch - Small / Bonnet, Headlight - Scratch - Minimal / Front Bumper, Grille, Lamps - Scratch - Medium / Roof - Scratch &amp; Dent - Small</p>
