## General Information

Date & Time: 16, Aug, 2025 10:46

<b>Make</b>	Toyota	<b>Model</b>	Veloz
<b>YOM</b>	2025	<b>Odo Meter Reading</b>	33,467
<b>Registration No.</b>	CCG6772	<b>Chassis No.</b>	MHFAB1BY5R3120237
<b>CC</b>	1.5	<b>Transmission</b>	CVT
<b>Fuel Type</b>	Gas	<b>Type of Body</b>	Wagon
<b>Colour</b>	Pearl White

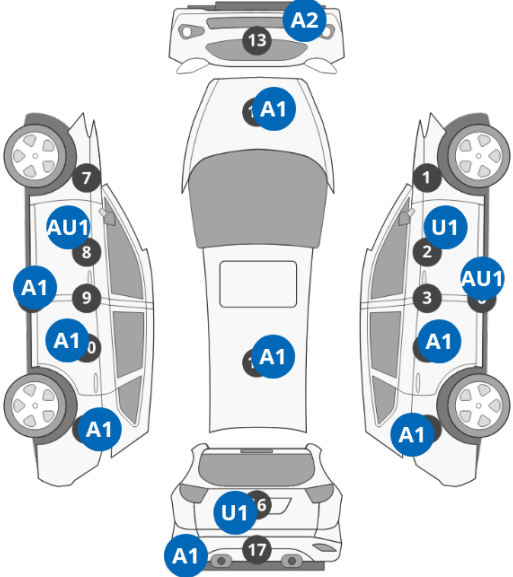
<p><b>A</b> : Scratch <b>AU</b> : Scratch &amp; Dent <b>B</b> : Modified <b>C</b> : Corrosion <b>G</b> : Stone chip <b>P</b> : Faded <b>S</b> : Rust <b>SC</b> : Rust &amp; Corrosion <b>U</b> : Dent <b>X</b> : Defective <b>Y</b> : Crack, Gap</p>
<p><b>Remarks</b> (L) Front Floor Mat - Worked - Small</p>	<p><b>Remarks</b> Roof - Repair Traces - Yes / (L) Front Door, Molding - Scratch &amp; Dent - Minimal / (L) Rear Door, Molding - Scratch - Minimal / (L) Rear Fender, Molding - Scratch - Minimal / (L) Step, In-panel, Side Spoiler - Scratch - Minimal / Front Bumper, Grille, Lamps - Scratch - Small / (R) Front Door, Molding - Dent - Minimal / (R) Rear Door, Molding - Scratch - Minimal / (R) Step, In-panel, Side Spoiler - Scratch &amp; Dent - Minimal / (R) Rear Fender, Molding - Scratch - Minimal / Roof - Scratch - Minimal / Bonnet, Headlight - Scratch - Minimal / Trunk Hood, Rear Gate - Dent - Minimal / Rear Bumper, Lamps, Panels - Scratch - Minimal</p>
