## General Information

Date & Time: 25, Nov, 2024 13:20

Make	Toyota	Model	Vios
YOM	2023	Mileage	61,699
Registration No.	DBG4705	Chassis No.	PA1B18F38P4200301
CC	1.3	Transmission	CVT
Fuel Type	Gas	Type of Body	Sedan
Colour	Blue

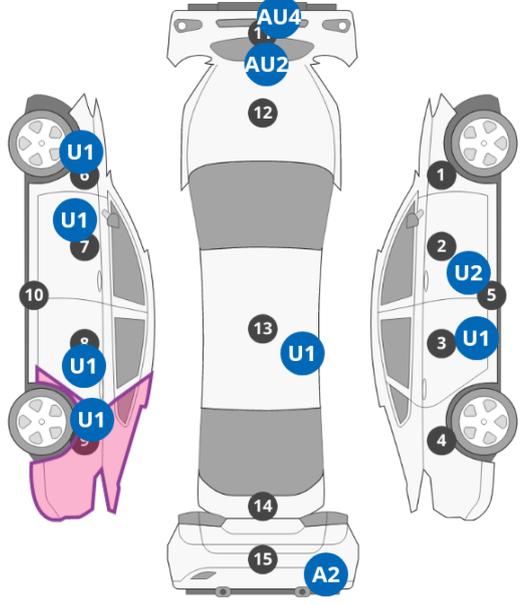
<p><b>A</b> : Scratch <b>AU</b> : Scratch &amp; Dent <b>B</b> : Modified <b>C</b> : Corrosion <b>G</b> : Stone chip <b>P</b> : Faded <b>S</b> : Rust <b>SC</b> : Rust &amp; Corrosion <b>U</b> : Dent <b>X</b> : Defective <b>Y</b> : Crack, Gap</p>
<p><b>Remarks</b> Overall Interior - Smell - Yes / Dashboard - Traces of Adhesive Tape - Yes / (L) Front Floor Mat - Grime - Small / Rear Seat - Grime - Medium / (R) Front Seat - Grime - Medium / Trunk Room - Worn, Scratch, Cut, Crack - Medium</p>	<p><b>Remarks</b> Bonnet, Headlight - Scratch &amp; Dent - Small / (R) Rear Door, Molding - Dent - Minimal / (R) Front Door, Molding - Dent - Small / Rear Bumper, Lamps, Panels - Scratch - Small / (L) Rear Fender, Molding - Dent - Minimal / (L) Front Fender, Molding - Dent - Minimal / (L) Front Door, Molding - Dent - Minimal / (L) Rear Door, Molding - Dent - Minimal / Front Bumper, Grille, Lamps - Scratch &amp; Dent - Large / Roof - Dent - Minimal / (L) Rear Wheel, Cover - Cap Missing - Yes</p>
