## General Information

<b>Make</b>	Toyota	<b>Model</b>	Vios
<b>YOM</b>	2022	<b>Odo Meter Reading</b>	66,379
<b>Registration No.</b>	CBD3801	<b>Chassis No.</b>	PA1B18F32N4175647
<b>CC</b>	1.3	<b>Transmission</b>	CVT
<b>Fuel Type</b>	Gas	<b>Type of Body</b>	Sedan
<b>Colour</b>	Blackish Red Mica

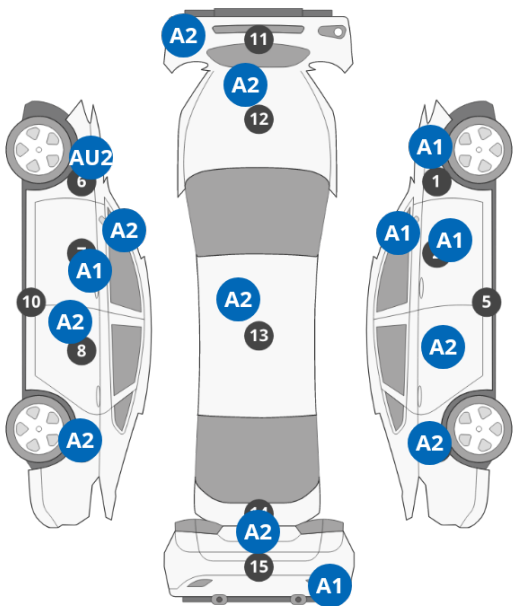
<p><b>A</b> : Scratch <b>AU</b> : Scratch &amp; Dent <b>B</b> : Modified <b>C</b> : Corrosion <b>G</b> : Stone chip <b>P</b> : Faded <b>S</b> : Rust <b>SC</b> : Rust &amp; Corrosion <b>U</b> : Dent <b>X</b> : Defective <b>Y</b> : Crack, Gap</p>
<p><b>Remarks</b> Rear Seat - Grime - Medium / (L) Front Trim - Grime - Small / (L) Front Seat - Grime - Small / (L) Front Floor Mat - Worked - Small / Ceiling - Grime - Minimal / (R) Front Seat - Grime - Medium</p>	<p><b>Remarks</b> (R) Front Fender, Molding - Scratch - Minimal / (R) Mirror - Scratch - Minimal / (R) Front Door, Molding - Scratch - Minimal / (R) Rear Door, Molding - Scratch - Small / (R) Rear Fender, Molding - Scratch - Small / Rear Bumper, Lamps, Panels - Scratch - Minimal / Trunk Hood, Rear Gate - Scratch - Small / (L) Rear Fender, Molding - Scratch - Small / (L) Rear Door, Molding - Scratch - Small / (L) Front Door, Molding - Scratch - Minimal / (L) Front Fender, Molding - Scratch &amp; Dent - Small / Front Bumper, Grille, Lamps - Scratch - Small / Bonnet, Headlight - Scratch - Small / Roof - Scratch - Small / (L) Mirror - Scratch - Small</p>
