## General Information

<b>Make</b>	Toyota	<b>Model</b>	Avanza
<b>YOM</b>	2024	<b>Odo Meter Reading</b>	26,733
<b>Registration No.</b>	DBM4926	<b>Chassis No.</b>	MHFAA1BY5R0023270
<b>CC</b>	1.3	<b>Transmission</b>	CVT
<b>Fuel Type</b>	Gas	<b>Type of Body</b>	MPV
<b>Colour</b>	Black

## Body / Panel Condition

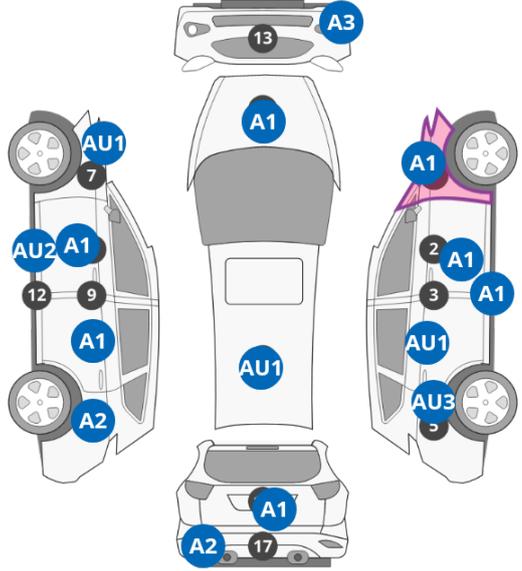
<p><b>A</b> : Scratch <b>AU</b> : Scratch &amp; Dent <b>B</b> : Modified <b>C</b> : Corrosion <b>G</b> : Stone chip <b>P</b> : Faded <b>S</b> : Rust <b>SC</b> : Rust &amp; Corrosion <b>U</b> : Dent <b>X</b> : Defective <b>Y</b> : Crack, Gap</p>
<p><b>Remarks</b> Overall Interior - Smell - Yes / Rear Seat - Grime - Small / (L) Front Trim - Worked - Small / (R) Front Trim - Worked - Small / (L) Front Floor Mat - Worked - Small / (L) Front Seat - Grime - Small / (R) Front Seat - Grime - Small</p>	<p><b>Remarks</b> (R) Front Fender - Repair Traces - Yes / (R) Step, In-panel, Side Spoiler - Scratch - Minimal / (R) Rear Fender, Molding - Scratch &amp; Dent - Medium / (R) Front Fender, Molding - Repair mark - Yes / (R) Rear Door, Molding - Scratch &amp; Dent - Minimal / (R) Front Door, Molding - Scratch - Minimal / (L) Step, In-panel, Side Spoiler - Scratch &amp; Dent - Small / (L) Rear Door, Molding - Scratch - Minimal / (L) Front Door, Molding - Scratch - Minimal / (L) Front Fender, Molding - Scratch &amp; Dent - Minimal / (L) Rear Fender, Molding - Scratch - Small / Rear Bumper, Lamps, Panels - Scratch - Small / Trunk Hood, Rear Gate - Scratch - Minimal / Front Bumper, Grille, Lamps - Scratch - Medium / (R) Front Fender, Molding - Scratch - Minimal / Bonnet, Headlight - Scratch - Minimal / Roof - Scratch &amp; Dent - Minimal</p>
