General Information

Make	Toyota	Model	Vios
YOM	2024	Odo Meter Reading	17,890
Registration No.	NHG2134-1	Chassis No.	PA1B18F30P4233440
CC	1.3	Transmission	CVT
Fuel Type	Gas	Type of Body	Sedan
Colour	Green

Body / Panel Condition

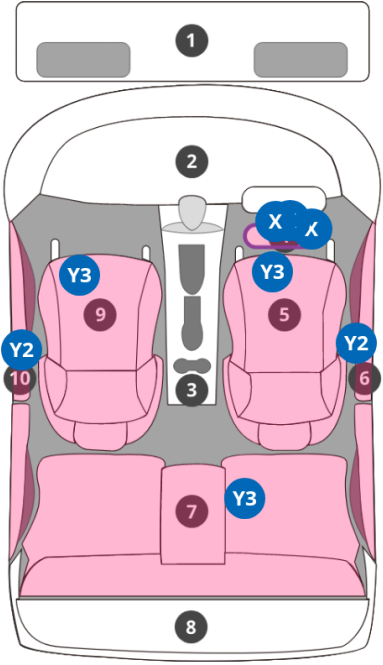
Interior Evaluation : B	Exterior Evaluation : C

<p>a : Cut, Fray d : Loose, Deformed k : Animal Hair s : Smell t : Cigarette Burns x : Defective y : Stain</p>

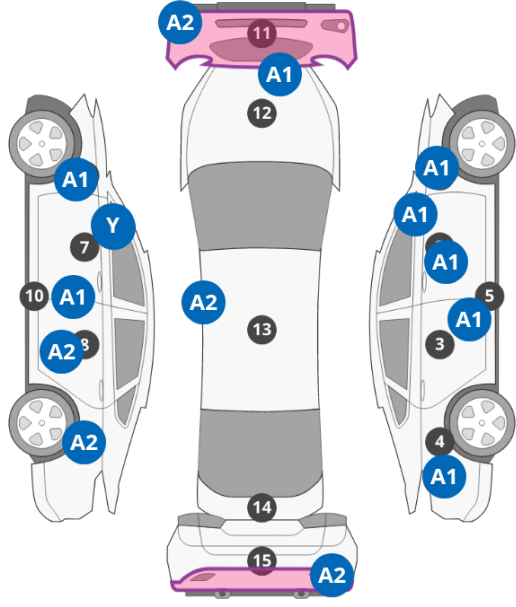
<p>A : Scratch AU : Scratch & Dent B : Modified C : Corrosion G : Stone chip P : Faded S : Rust SC : Rust & Corrosion U : Dent X : Defective Y : Crack, Gap</p>
<p>Remarks (R) Front Seat - Grime - Medium / (L) Front Seat - Grime - Medium / (L) Front Trim - Grime - Small / (R) Front Trim - Grime - Small / Rear Seat - Grime - Medium / Mat Other - Missing - Yes / (L) Front Floor Mat - Missing - Yes / (R) Front Floor Mat - Missing - Yes</p>	<p>Remarks (R) Front Fender - Repair Traces - Yes / (L) Front Door - Repair Traces - Yes / Trunk Hood, Rear Gate - Repair Traces - Yes / (R) Front Fender, Molding - Scratch - Minimal / (R) Mirror - Scratch - Minimal / (R) Front Door, Molding - Scratch - Minimal / (R) Rear Door, Molding - Scratch - Minimal / (R) Rear Fender, Molding - Scratch - Minimal / Rear Bumper, Lamps, Panels - Repair mark - Yes / Rear Bumper, Lamps, Panels - Scratch - Small / (L) Rear Fender, Molding - Scratch - Small / (L) Rear Door, Molding - Scratch - Small / (L) Front Door, Molding - Scratch - Minimal / (L) Mirror - Scratch - Minimal / (L) Mirror - Crack - Cracks / (L) Front Fender, Molding - Scratch - Minimal / Front Bumper, Grille, Lamps - Scratch - Small / Front Bumper, Grille, Lamps - Repair mark - Yes / Bonnet, Headlight - Scratch - Minimal / Roof - Scratch - Small</p>
