## General Information

<b>Make</b>	Toyota	<b>Model</b>	Innova
<b>YOM</b>	2020	<b>Mileage</b>	28,568
<b>Registration No.</b>	NFZ8472	<b>Chassis No.</b>	PA2JA8EMXL0077992
<b>CC</b>	2.8	<b>Transmission</b>	A/T
<b>Fuel Type</b>	Diesel	<b>Type of Body</b>	MPV
<b>Colour</b>	BLACKISH RED MICA

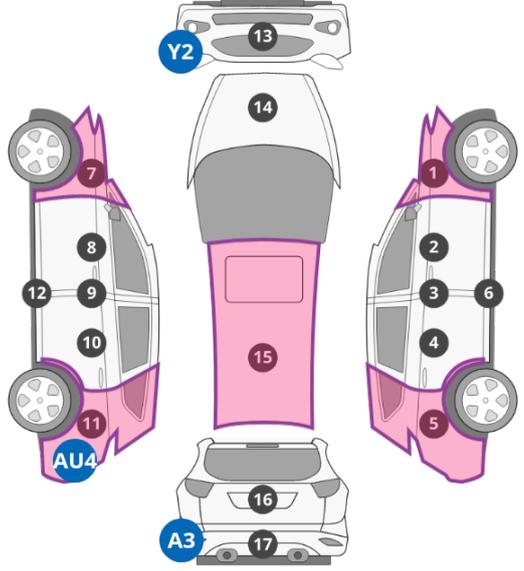
<p><b>A</b> : Scratch <b>AU</b> : Scratch &amp; Dent <b>B</b> : Modified <b>C</b> : Corrosion <b>G</b> : Stone chip <b>P</b> : Faded <b>S</b> : Rust <b>SC</b> : Rust &amp; Corrosion <b>U</b> : Dent <b>X</b> : Defective <b>Y</b> : Crack, Gap</p>
<p><b>Remarks</b></p> <p>Rear Seat - Missing - Yes / Mat Other - Missing - Yes / (R) Front Floor Mat - Missing - Yes / (L) Front Floor Mat - Missing - Yes / Switchs - Missing - Yes / Switchs - Missing - Yes / Trim Other - Missing - Yes / Trim Other - Missing - Yes / Trim Other - Missing - Yes / Glove Box - Loose, Deformed - Large / Dashboard - Loose, Deformed - Large / Display, Audio System - Missing - Yes / Room Mirror - Missing - Yes / (R) Front Seat Head Rest - Missing - Yes / (L) Front Seat Head Rest - Missing - Yes / Rear Seat Head Rest - Missing - Yes / Sunvisor, Sunglass Holder - Missing - Yes / Room Mirror - Missing - Yes / Switchs - Missing - Yes / (L) Front Trim - Loose, Deformed - Large / (L) Rear Trim - Loose, Deformed - Medium / (R) Front Trim - Loose, Deformed - Large / (R) Rear Trim - Loose, Deformed - Large / Seat belt Other - Loose, Deformed - Large</p>	<p><b>Remarks</b></p> <p>(R) Rear Wheel, Cover - Cap Missing - Yes / (R) Front Wheel, Cover - Cap Missing - Yes / (L) Front Wheel, Cover - Cap Missing - Yes / (L) Rear Wheel, Cover - Cap Missing - Yes / Front Bumper, Grille, Lamps - Crack, Gap - Small / (L) Rear Fender, Molding - Scratch &amp; Dent - Large / Rear Bumper, Lamps, Panels - Scratch - Medium / Roof Spoiler, Molding - Partially Missing - Yes</p>
