General Information

Date & Time: 03, Dec, 2024 17:50

Make	Toyota	Model	Vios
YOM	2021	Mileage	102,012
Registration No.	NGR8101	Chassis No.	PA1B18F36L4131845
CC	1.3	Transmission	CVT
Fuel Type	Gas	Type of Body	Sedan
Colour	Green

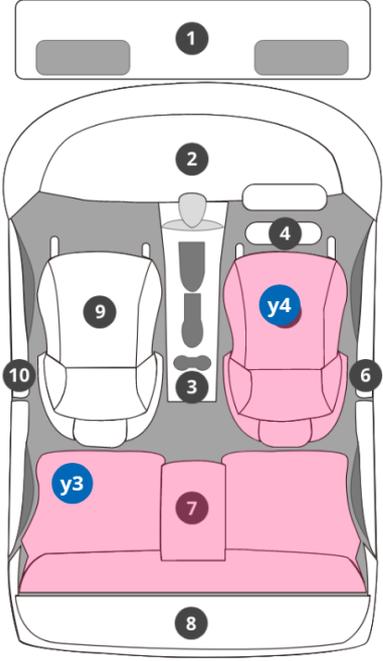
Interior Evaluation : C	Exterior Evaluation : C

<p>a : Cut, Fray d : Loose, Deformed k : Animal Hair s : Smell t : Cigarette Burns x : Defective y : Stain</p>

<p>A : Scratch AU : Scratch & Dent B : Modified C : Corrosion G : Stone chip P : Faded S : Rust SC : Rust & Corrosion U : Dent X : Defective Y : Crack, Gap</p>
<p>Remarks Rear Seat - Grime - Medium / (R) Front Seat - Grime - Large</p>	<p>Remarks Bonnet - Repair Traces - Yes / Bonnet, Headlight - Scratch & Dent - Small / (R) Front Door, Molding - Dent - Small / Front Bumper, Grille, Lamps - Crack, Gap - Medium / (R) Rear Fender, Molding - Dent - Minimal / (R) Rear Door, Molding - Dent - Minimal / Roof - Dent - Small / (L) Mirror - Scratch - Small / (L) Front Door, Molding - Scratch & Dent - Minimal / (L) Step, In-panel, Side Spoiler - Scratch & Dent - Large / Trunk Hood, Rear Gate - Scratch & Dent - Minimal / Rear Bumper, Lamps, Panels - Scratch & Dent - Small</p>
