## General Information

| Make | Toyota | Model | Hiace |
| Registration No. | DAP4259 | Chassis No. | JTFJT02P2M5028162 |

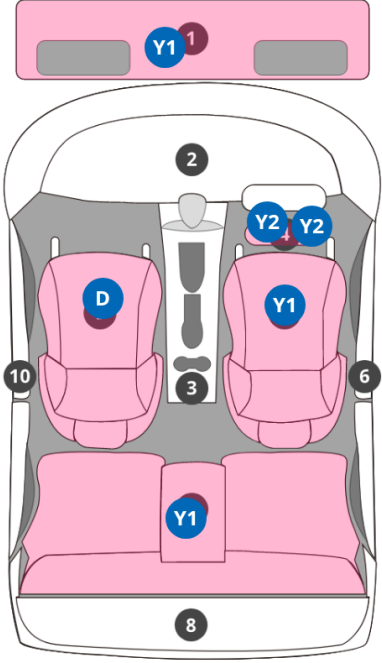
| Interior Evaluation : <b>B</b> | Exterior Evaluation : <b>D</b> |
| <p><b>Remarks</b></p> <p>Rear Seat - Grime - Minimal / (R) Front Seat - Grime - Minimal / (L) Front Seat - Worn - Yes / (R) Front Floor Mat - Grime - Small / (L) Front Floor Mat - Grime - Small / Ceiling - Grime - Minimal</p> | <p><b>Remarks</b></p> <p>(R) Rear Fender - Repair Traces - Yes / (R) Rear Fender, Molding - Repair mark - Yes / Trunk Hood, Rear Gate - Repair mark - Yes / (L) Mirror - Scratch - Minimal / (L) Front Door, Molding - Scratch - Small / (L) Step, In-panel, Side Spoiler - Scratch - Medium / (L) Rear Fender, Molding - Scratch &amp; Dent - Small / Trunk Hood, Rear Gate - Scratch - Small / Rear Bumper, Lamps, Panels - Scratch - Medium / (R) Rear Fender, Molding - Scratch - Small / (R) Rear Door, Molding - Scratch - Small / (R) Center Panel - Scratch - Small / (R) Front Door, Molding - Scratch - Small / (R) Mirror - Scratch - Minimal / Front Bumper, Grille, Lamps - Scratch - Medium / Front Panel - Scratch - Minimal / Roof - Rust, Corrosion - Small</p> |
