## General Information

<b>Make</b>	Toyota	<b>Model</b>	Hilux
<b>YOM</b>	2023	<b>Odo Meter Reading</b>	29,831
<b>Registration No.</b>	NIF8208	<b>Chassis No.</b>	MRAB8DD5N145265
<b>CC</b>	2.4	<b>Transmission</b>	M/T
<b>Fuel Type</b>	Diesel	<b>Type of Body</b>	Pickup
<b>Colour</b>	Green

## Body / Panel Condition

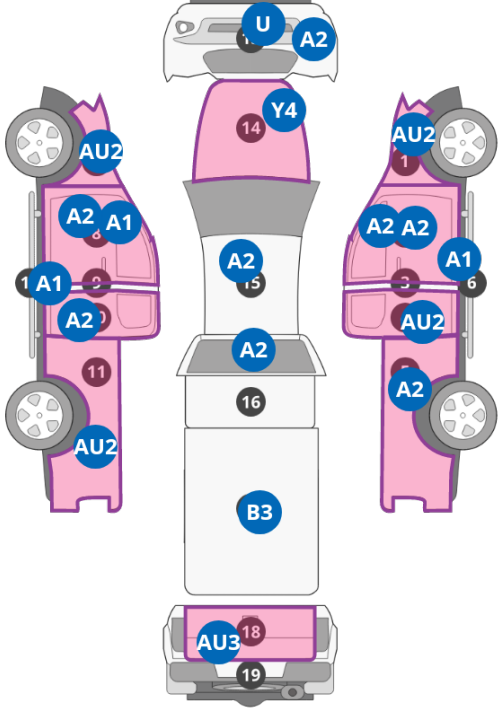
<p><b>A</b> : Scratch <b>AU</b> : Scratch &amp; Dent <b>B</b> : Modified <b>C</b> : Corrosion <b>G</b> : Stone chip <b>P</b> : Faded <b>S</b> : Rust <b>SC</b> : Rust &amp; Corrosion <b>U</b> : Dent <b>X</b> : Defective <b>Y</b> : Crack, Gap</p>
<b>Remarks</b> Overall Interior - Animal Hair - Yes / (L) Front Floor Mat - Crinkle - Small	<b>Remarks</b> (R) Front Door - Repair Traces - Yes / (R) Front Fender - Repair Traces - Yes / Bonnet - Repair Traces - Yes / (L) Front Fender - Repair Traces - Yes / (L) Front Door - Repair Traces - Yes / (L) Rear Door - Repair Traces - Yes / (L) Rear Corner Panel - Repair Traces - Yes / (R) Rear Door - Repair Traces - Yes / Roof - Repair Traces - Yes / (R) Side Gate - Repair mark - Yes / (L) Side Gate - Repair mark - Yes / (R) Rear Door, Molding - Repair mark - Yes / (R) Front Door, Molding - Repair mark - Yes / (L) Rear Door, Molding - Repair mark - Yes / (L) Front Door, Molding - Repair mark - Yes / (R) Front Fender, Molding - Repair mark - Yes / Bonnet, Headlight - Repair mark - Yes / Member (Bolted) - Dent - Yes / Overall Exterior - Faded(Color, Gloss) - Yes / Bonnet, Headlight - Crack, Gap - Large / Front Bumper, Grille, Lamps - Scratch - Small / (R) Mirror - Scratch - Small / (L) Mirror - Scratch - Minimal / (R) Front Fender, Molding - Scratch & Dent - Small / (L) Front Fender, Molding - Scratch & Dent - Small / (L) Front Door, Molding - Scratch - Small / (L) Rear Door, Molding - Scratch - Small / (L) Step, In-panel, Side Spoiler - Scratch - Minimal / (R) Rear Door, Molding - Scratch & Dent - Small / (R) Front Door, Molding - Scratch - Small / (R) Side Gate - Scratch - Small / (L) Side Gate - Scratch & Dent - Small / Rear Gate - Partially Missing - Yes / Rear Gate - Scratch & Dent - Medium / Cab Back Panel - Scratch - Small / Cargo Bed Floor - Modified - Medium / Roof - Scratch - Small
