General Information

Date & Time: 10, Sep, 2025 15:58

Make	Toyota	Model	Hilux
YOM	2013	Odo Meter Reading	414,877
Registration No.	UPO978	Chassis No.	MR0ER320K86928674
CC	2.5	Transmission	M/T
Fuel Type	Diesel	Type of Body	Pickup
Colour	Black

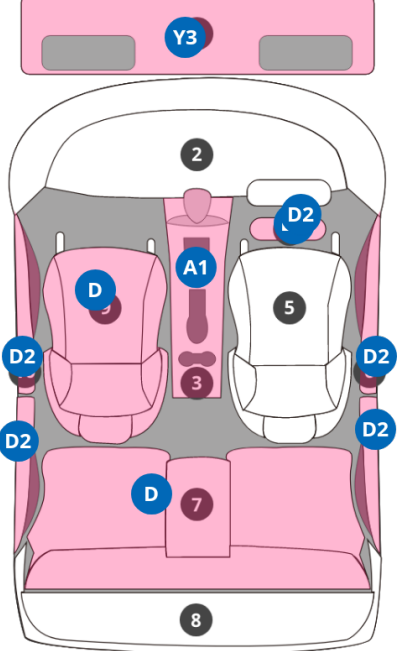
Interior Evaluation : C	Exterior Evaluation : E

<p>A : Scratch AU : Scratch & Dent B : Modified C : Corrosion G : Stone chip P : Faded S : Rust SC : Rust & Corrosion U : Dent X : Defective Y : Crack, Gap</p>
<p>Remarks Rear Seat - Worn - Yes / Ceiling - Grime - Medium / Overall Interior - Worn as per age - Yes / (L) Front Seat - Worn - Yes / (L) Front Floor Mat - Worked - Large / (R) Front Floor Mat - Worked - Small / Console, Switches, Vents - Worn, Scratch, Cut, Crack - Minimal / (L) Front Trim - Worked - Small / (R) Front Trim - Worked - Small / (R) Rear Trim - Worked - Small / (L) Rear Trim - Worked - Small</p>	<p>Remarks (R) Front Door - Repair Traces - Yes / (R) Front Fender - Repair Traces - Yes / Bonnet - Repair Traces - Yes / (L) Front Door - Repair Traces - Yes / (L) Center Panel - Repair Traces - Yes / (L) Rear Door - Repair Traces - Yes / (R) Rear Door - Repair Traces - Yes / (R) Center Panel - Repair Traces - Yes / Cargo Bed Floor - Modified - Large / Cargo Bed Floor - Scratch - Small / Member (Bolted) - Dent - Yes / Overall Exterior - Full Re-Paint in same color - Yes / Overall Exterior - Faded(Color, Gloss) - Yes / Overall Exterior - Worn as per age - Yes / (R) Front Fender, Molding - Scratch - Medium / (R) Mirror - Scratch - Small / (R) Step, In-panel, Side Spoiler - Modified - Large / (R) Front Door, Molding - Scratch - Small / (R) Rear Door, Molding - Scratch - Medium / (R) Side Gate - Scratch - Large / Rear Gate - Scratch - Small / Rear Bumper, Lamps, Panels - Rust, Corrosion - Medium / Roof - Modified - Medium / (L) Side Gate - Scratch - Large / (L) Step, In-panel, Side Spoiler - Modified - Large / (L) Rear Door, Molding - Scratch - Small / (L) Front Door, Molding - Scratch - Small / (L) Mirror - Scratch - Small / (L) Front Fender, Molding - Scratch - Small / Front Bumper, Grille, Lamps - Scratch - Medium / Bonnet, Headlight - Scratch - Small</p>
