## General Information

<b>Make</b>	Toyota	<b>Model</b>	Vios
<b>YOM</b>	2024	<b>Odo Meter Reading</b>	46,010
<b>Registration No.</b>	EAG6012	<b>Chassis No.</b>	PA1B18F38P4230737
<b>CC</b>	1.3	<b>Transmission</b>	CVT
<b>Fuel Type</b>	Gas	<b>Type of Body</b>	Sedan
<b>Colour</b>	Red Mica Metallic

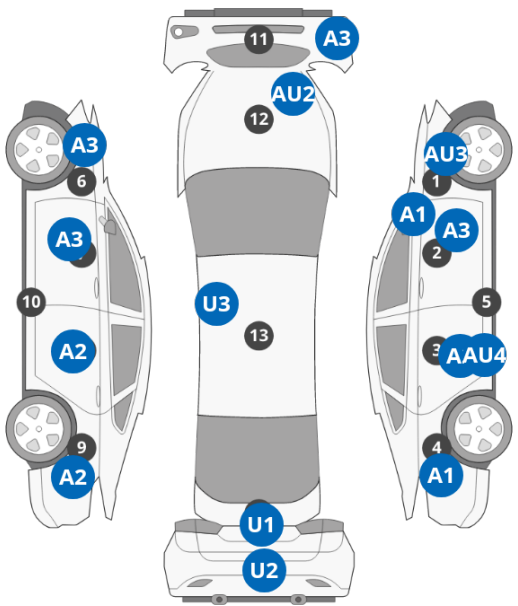
<p><b>A</b> : Scratch <b>AU</b> : Scratch &amp; Dent <b>B</b> : Modified <b>C</b> : Corrosion <b>G</b> : Stone chip <b>P</b> : Faded <b>S</b> : Rust <b>SC</b> : Rust &amp; Corrosion <b>U</b> : Dent <b>X</b> : Defective <b>Y</b> : Crack, Gap</p>
<p><b>Remarks</b> Trunk Room - Worn, Scratch, Cut, Crack - Medium / Rear Seat - Grime - Large / (R) Front Seat - Grime - Medium / (R) Front Trim - Grime - Small / (R) Front Floor Mat - Missing - Yes / Mat Other - Missing - Yes / (L) Front Trim - Grime - Medium / (L) Front Seat - Grime - Medium / (L) Front Floor Mat - Grime - Medium / Dashboard - Worn, Scratch, Cut, Crack - Small / Ceiling - Grime - Small / Console, Switches, Vents - Worn, Scratch, Cut, Crack - Minimal</p>	<p><b>Remarks</b> (L) Rear Fender - Repair Traces - Yes / (L) Rear Fender, Molding - Scratch - Small / Rear Bumper, Lamps, Panels - Dent - Small / Trunk Hood, Rear Gate - Dent - Minimal / (R) Rear Fender, Molding - Scratch - Minimal / (R) Rear Door, Molding - Scratch - Small / (R) Front Door, Molding - Scratch - Medium / (R) Step, In-panel, Side Spoiler - Scratch &amp; Dent - Large / (R) Mirror - Scratch - Minimal / (R) Front Fender, Molding - Scratch &amp; Dent - Medium / Bonnet, Headlight - Scratch &amp; Dent - Small / Front Bumper, Grille, Lamps - Scratch - Medium / (L) Front Fender, Molding - Scratch - Medium / (L) Front Door, Molding - Scratch - Medium / (L) Rear Door, Molding - Scratch - Small / Roof - Dent - Medium</p>
