## General Information

Date & Time: 04, Sep, 2025 13:32

<b>Make</b>	Toyota	<b>Model</b>	Vios
<b>YOM</b>	2021	<b>Odo Meter Reading</b>	27,910
<b>Registration No.</b>	NFI2232	<b>Chassis No.</b>	PA1B18F34M4147463
<b>CC</b>	1.3	<b>Transmission</b>	CVT
<b>Fuel Type</b>	Gas	<b>Type of Body</b>	Sedan
<b>Colour</b>	White

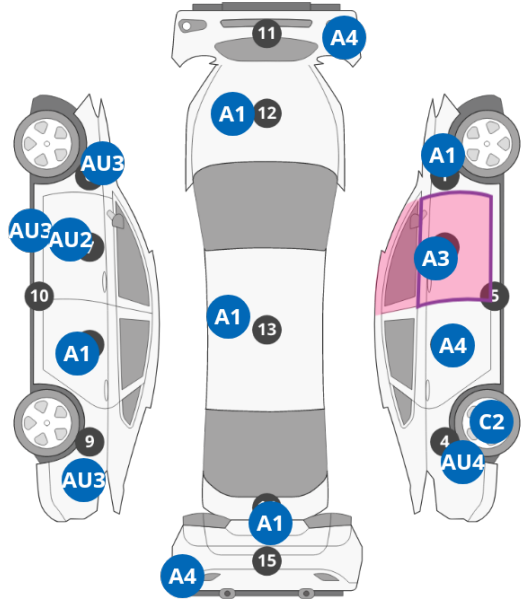
<p><b>A</b> : Scratch <b>AU</b> : Scratch &amp; Dent <b>B</b> : Modified <b>C</b> : Corrosion <b>G</b> : Stone chip <b>P</b> : Faded <b>S</b> : Rust <b>SC</b> : Rust &amp; Corrosion <b>U</b> : Dent <b>X</b> : Defective <b>Y</b> : Crack, Gap</p>
<b>Remarks</b> (R) Front Seat - Grime - Large / (R) Front Trim - Grime - Small / (R) Front Floor Mat - Grime - Medium / Rear Seat - Grime - Large / Trunk Room - Worn, Scratch, Cut, Crack - Small / (L) Front Floor Mat - Grime - Medium / (L) Front Trim - Grime - Small / (L) Front Seat - Grime - Small / Steering Wheel - Worn, Peel, Crack - Medium / Ceiling - Grime - Small / Overall Interior - Smell - Yes / Dashboard - Worn, Scratch, Cut, Crack - Small / Mat Other - Missing - Yes	<b>Remarks</b> (R) Front Door - Repair Traces - Yes / (L) Rear Fender, Molding - Scratch & Dent - Medium / Rear Bumper, Lamps, Panels - Scratch - Large / (R) Rear Fender, Molding - Scratch & Dent - Large / (R) Rear Door, Molding - Scratch - Large / (R) Front Door, Molding - Repair mark - Yes / (R) Front Door, Molding - Scratch - Medium / Front Bumper, Grille, Lamps - Scratch - Large / (L) Front Fender, Molding - Scratch & Dent - Medium / (L) Step, In-panel, Side Spoiler - Scratch & Dent - Medium / (L) Front Door, Molding - Scratch & Dent - Small / Trunk Hood, Rear Gate - Scratch - Minimal / (L) Rear Door, Molding - Scratch - Minimal / Bonnet, Headlight - Scratch - Minimal / Roof - Scratch - Minimal / (R) Front Fender, Molding - Scratch - Minimal / (R) Rear Wheel, Cover - Scratch, Corrosion - Small
