## General Information

Date & Time: 05, Sep, 2025 09:08

<b>Make</b>	Toyota	<b>Model</b>	Wigo
<b>YOM</b>	2024	<b>Odo Meter Reading</b>	14,993
<b>Registration No.</b>	YAB5053	<b>Chassis No.</b>	MHKAA1BCOPJ009001
<b>CC</b>	1.0	<b>Transmission</b>	CVT
<b>Fuel Type</b>	Gas	<b>Type of Body</b>	Hatchback
<b>Colour</b>	Gray

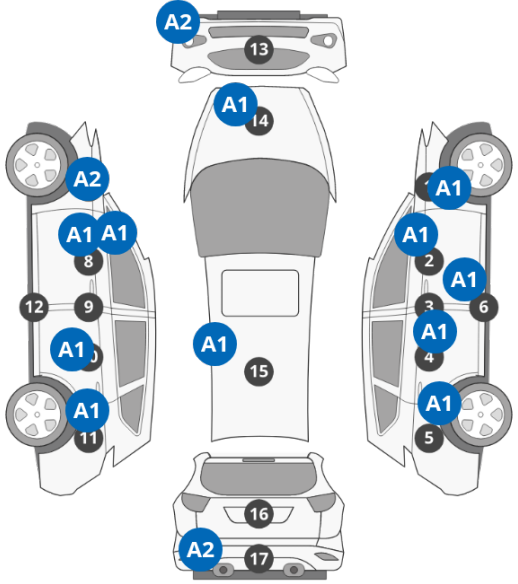
<p><b>A</b> : Scratch <b>AU</b> : Scratch &amp; Dent <b>B</b> : Modified <b>C</b> : Corrosion <b>G</b> : Stone chip <b>P</b> : Faded <b>S</b> : Rust <b>SC</b> : Rust &amp; Corrosion <b>U</b> : Dent <b>X</b> : Defective <b>Y</b> : Crack, Gap</p>
<p><b>Remarks</b> (L) Front Floor Mat - Worked - Small / (R) Front Seat - Grime - Minimal / (L) Front Seat - Grime - Minimal / Rear Seat - Grime - Small / Ceiling - Grime - Minimal</p>	<p><b>Remarks</b> (R) Front Fender, Molding - Scratch - Minimal / (R) Mirror - Scratch - Minimal / (R) Front Door, Molding - Scratch - Minimal / (R) Rear Door, Molding - Scratch - Minimal / (R) Rear Fender, Molding - Scratch - Minimal / Rear Bumper, Lamps, Panels - Scratch - Small / (L) Rear Fender, Molding - Scratch - Minimal / (L) Rear Door, Molding - Scratch - Minimal / (L) Front Door, Molding - Scratch - Minimal / (L) Mirror - Scratch - Minimal / (L) Front Fender, Molding - Scratch - Small / Front Bumper, Grille, Lamps - Scratch - Small / Bonnet, Headlight - Scratch - Minimal / Roof - Scratch - Minimal</p>
