## General Information

Date & Time: 05, Sep, 2025 09:50

<b>Make</b>	Toyota	<b>Model</b>	Raize
<b>YOM</b>	2022	<b>Odo Meter Reading</b>	45,023
<b>Registration No.</b>	NFK9326	<b>Chassis No.</b>	MHKAA1BA3NJ037385
<b>CC</b>	1.0	<b>Transmission</b>	CVT
<b>Fuel Type</b>	Gas	<b>Type of Body</b>	SUV
<b>Colour</b>	White

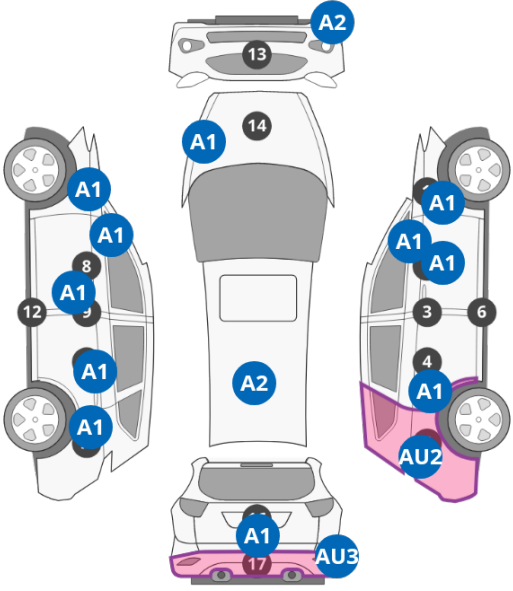
<p><b>A</b> : Scratch <b>AU</b> : Scratch &amp; Dent <b>B</b> : Modified <b>C</b> : Corrosion <b>G</b> : Stone chip <b>P</b> : Faded <b>S</b> : Rust <b>SC</b> : Rust &amp; Corrosion <b>U</b> : Dent <b>X</b> : Defective <b>Y</b> : Crack, Gap</p>
<p><b>Remarks</b> Ceiling - Grime - Medium / Console, Switches, Vents - Worn, Scratch, Cut, Crack - Medium</p>	<p><b>Remarks</b> (R) Front Fender, Molding - Scratch - Minimal / (R) Mirror - Scratch - Minimal / (R) Front Door, Molding - Scratch - Minimal / (R) Rear Door, Molding - Scratch - Minimal / (R) Rear Fender, Molding - Repair mark - Yes / (R) Rear Fender, Molding - Scratch &amp; Dent - Small / Rear Bumper, Lamps, Panels - Repair mark - Yes / Rear Bumper, Lamps, Panels - Scratch &amp; Dent - Medium / Trunk Hood, Rear Gate - Scratch - Minimal / (L) Rear Fender, Molding - Scratch - Minimal / (L) Rear Door, Molding - Scratch - Minimal / (L) Front Door, Molding - Scratch - Minimal / (L) Front Fender, Molding - Scratch - Minimal / (L) Mirror - Scratch - Minimal / Front Bumper, Grille, Lamps - Scratch - Small / Bonnet, Headlight - Scratch - Minimal / Roof - Scratch - Small</p>
