General Information

| Make | Toyota | Model | Avanza |
| Registration No. | NHS6967 | Chassis No. | MHFAA1BY7R0028678 |

Body / Panel Condition

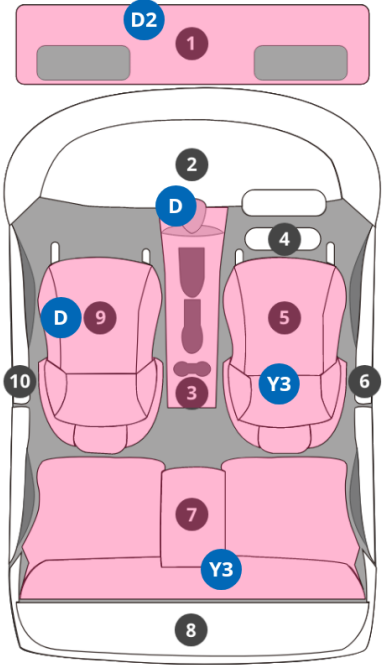
| Interior Evaluation : B | Exterior Evaluation : C |
| <p>Remarks (L) Front Seat - Worn - Yes / (R) Front Seat - Grime - Medium / Rear Seat - Grime - Medium / Console, Switches, Vents - Traces of Adhesive Tape - Yes / Ceiling - Crinkle - Small</p> | <p>Remarks (R) Front Fender, Molding - Scratch - Minimal / (R) Mirror - Scratch - Minimal / (R) Front Door, Molding - Scratch - Small / (R) Rear Door, Molding - Scratch - Small / (R) Rear Fender, Molding - Scratch - Minimal / Rear Bumper, Lamps, Panels - Scratch - Medium / Trunk Hood, Rear Gate - Scratch - Minimal / (L) Rear Fender, Molding - Scratch & Dent - Minimal / (L) Rear Door, Molding - Scratch - Minimal / (L) Front Door, Molding - Scratch - Small / (L) Mirror - Scratch - Minimal / (L) Front Fender, Molding - Scratch - Minimal / Front Bumper, Grille, Lamps - Scratch & Dent - Small / Bonnet, Headlight - Scratch - Minimal / Roof - Scratch & Dent - Minimal</p> |
