## General Information

<b>Make</b>	Toyota	<b>Model</b>	Vios
<b>YOM</b>	2024	<b>Odo Meter Reading</b>	22,124
<b>Registration No.</b>	DBO1509	<b>Chassis No.</b>	PA1B18F38P4237963
<b>CC</b>	1.3	<b>Transmission</b>	CVT
<b>Fuel Type</b>	Gas	<b>Type of Body</b>	Sedan
<b>Colour</b>	Black

## Body / Panel Condition

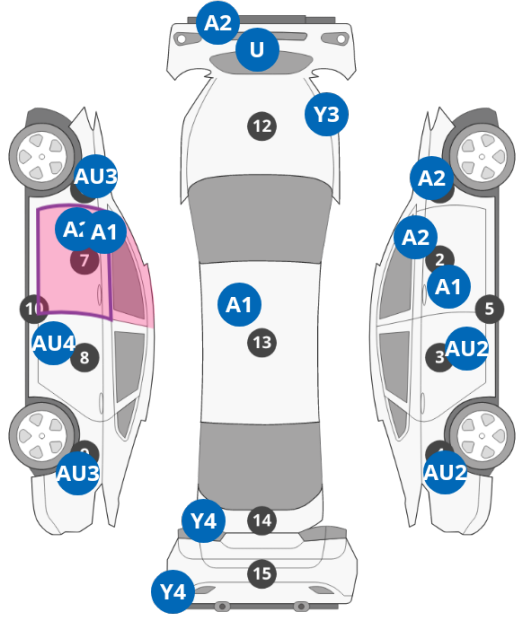
<p><b>A</b> : Scratch <b>AU</b> : Scratch &amp; Dent <b>B</b> : Modified <b>C</b> : Corrosion <b>G</b> : Stone chip <b>P</b> : Faded <b>S</b> : Rust <b>SC</b> : Rust &amp; Corrosion <b>U</b> : Dent <b>X</b> : Defective <b>Y</b> : Crack, Gap</p>
<p><b>Remarks</b>  (R) Front Seat - Grime - Medium / (L) Front Seat - Worn - Yes / Rear Seat - Grime - Small / (R) Front Trim - Grime - Minimal / (R) Rear Trim - Cut, Crack - Minimal / Ceiling - Grime - Minimal</p>	<p><b>Remarks</b>  (R) Front Fender, Molding - Scratch - Small / (R) Mirror - Scratch - Small / (R) Front Door, Molding - Scratch - Minimal / (R) Rear Door, Molding - Scratch &amp; Dent - Small / (R) Rear Fender, Molding - Scratch &amp; Dent - Small / Trunk Hood, Rear Gate - Crack, Gap - Large / Rear Bumper, Lamps, Panels - Crack, Gap - Large / (L) Rear Fender, Molding - Scratch &amp; Dent - Medium / (L) Rear Door, Molding - Scratch &amp; Dent - Large / (L) Front Door, Molding - Repair mark - Yes / (L) Front Door, Molding - Scratch - Small / (L) Front Fender, Molding - Scratch &amp; Dent - Medium / (L) Mirror - Scratch - Minimal / Member (Bolted) - Dent - Yes / Front Bumper, Grille, Lamps - Scratch - Small / Bonnet, Headlight - Crack, Gap - Medium / Roof - Scratch - Minimal</p>
