## General Information

<b>Make</b>	Suzuki	<b>Model</b>	Dzire
<b>YOM</b>	2024	<b>Odo Meter Reading</b>	46,684
<b>Registration No.</b>	NIU5207	<b>Chassis No.</b>	MBHZF63S6RG468741
<b>CC</b>	1.2	<b>Transmission</b>	M/T
<b>Fuel Type</b>	Gas	<b>Type of Body</b>	Sedan
<b>Colour</b>	Gray

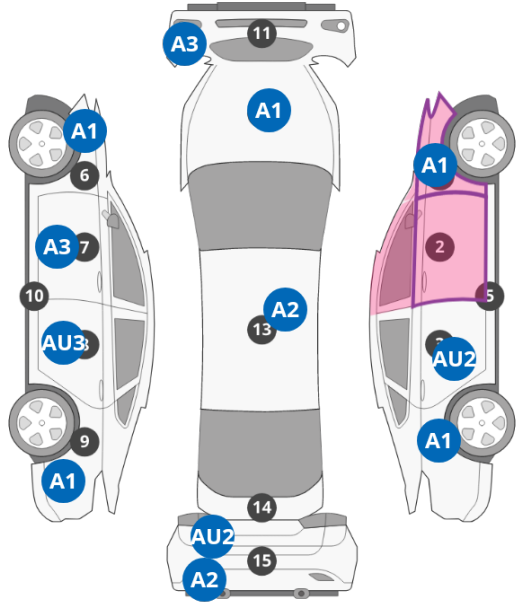
<p><b>A</b> : Scratch <b>AU</b> : Scratch &amp; Dent <b>B</b> : Modified <b>C</b> : Corrosion <b>G</b> : Stone chip <b>P</b> : Faded <b>S</b> : Rust <b>SC</b> : Rust &amp; Corrosion <b>U</b> : Dent <b>X</b> : Defective <b>Y</b> : Crack, Gap</p>
<p><b>Remarks</b> Rear Seat - Grime - Medium / (R) Front Trim - Grime - Small / (R) Front Seat - Grime - Large / (L) Front Trim - Grime - Medium / (L) Front Seat - Grime - Large / (L) Front Floor Mat - Grime - Small / Dashboard - Traces of Adhesive Tape - Yes / Ceiling - Grime - Minimal</p>	<p><b>Remarks</b> (R) Front Door - Repair Traces - Yes / (R) Front Fender - Repair Traces - Yes / Bonnet - Repair Traces - Yes / (L) Front Door - Repair Traces - Yes / (L) Rear Door - Repair Traces - Yes / (L) Rear Fender - Repair Traces - Yes / Trunk Hood, Rear Gate - Repair Traces - Yes / (R) Rear Fender - Repair Traces - Yes / (R) Rear Door - Repair Traces - Yes / Roof - Repair Traces - Yes / (R) Rear Door, Molding - Scratch &amp; Dent - Small / Rear Bumper, Lamps, Panels - Scratch - Small / (R) Rear Fender, Molding - Scratch - Minimal / (R) Front Fender, Molding - Repair mark - Yes / (R) Front Door, Molding - Repair mark - Yes / (R) Front Fender, Molding - Scratch - Minimal / Front Bumper, Grille, Lamps - Scratch - Medium / (L) Front Fender, Molding - Scratch - Minimal / (L) Rear Fender, Molding - Scratch - Minimal / (L) Rear Door, Molding - Scratch &amp; Dent - Medium / (L) Front Door, Molding - Scratch - Medium / Roof - Scratch - Small / Bonnet, Headlight - Scratch - Minimal / Trunk Hood, Rear Gate - Scratch &amp; Dent - Small</p>
