General Information

| Make | Toyota | Model | Vios |

Body / Panel Condition

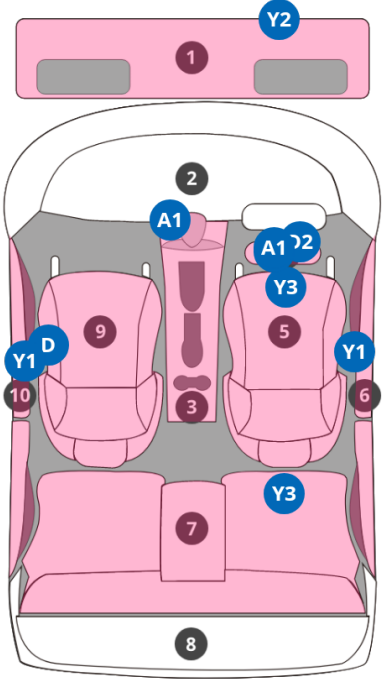
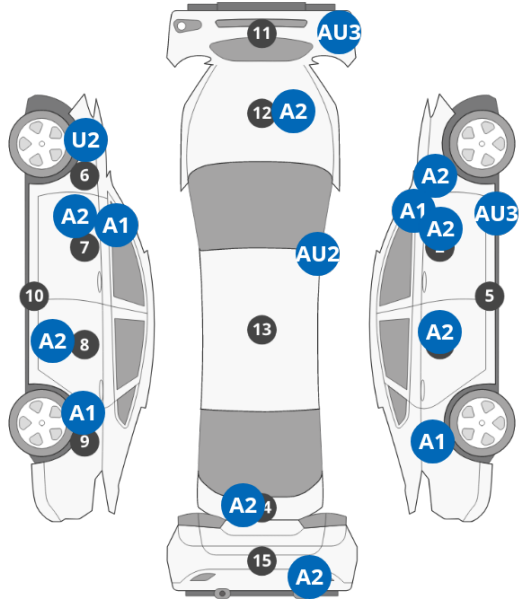
| Interior Evaluation : C | Exterior Evaluation : D |

| <p>Remarks (L) Front Seat - Worn - Yes / (R) Front Seat - Grime - Medium / Rear Seat - Grime - Medium / (R) Front Floor Mat - Worked - Small / (L) Front Floor Mat - Worked - Large / (L) Front Floor Mat - Cut, Crack - Minimal / (R) Front Trim - Grime - Minimal / (L) Front Trim - Grime - Minimal / Console, Switches, Vents - Worn, Scratch, Cut, Crack - Minimal / Ceiling - Grime - Small</p> | <p>Remarks Roof - Scratch & Dent - Small / (R) Front Fender, Molding - Scratch - Small / (R) Mirror - Scratch - Minimal / (R) Step, In-panel, Side Spoiler - Scratch & Dent - Medium / (R) Front Door, Molding - Scratch - Small / (R) Rear Door, Molding - Scratch - Small / (R) Rear Fender, Molding - Scratch - Minimal / Rear Bumper, Lamps, Panels - Scratch - Small / Trunk Hood, Rear Gate - Scratch - Small / (L) Rear Fender, Molding - Scratch - Minimal / (L) Rear Door, Molding - Scratch - Small / (L) Front Door, Molding - Scratch - Small / (L) Mirror - Scratch - Minimal / (L) Front Fender, Molding - Dent - Small / Front Bumper, Grille, Lamps - Scratch & Dent - Medium / Bonnet, Headlight - Scratch - Small</p> |
