## General Information

Date & Time: 05, Sep, 2025 15:06

<b>Make</b>	Toyota	<b>Model</b>	Vios
<b>YOM</b>	2023	<b>Odo Meter Reading</b>	36,502
<b>Registration No.</b>	DAS7523	<b>Chassis No.</b>	PA1B18F39N4194831
<b>CC</b>	1.3	<b>Transmission</b>	CVT
<b>Fuel Type</b>	Gas	<b>Type of Body</b>	Sedan
<b>Colour</b>	Red Mica Metallic

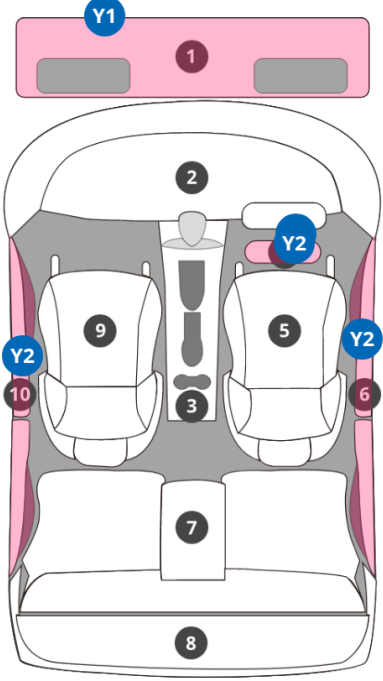
<b>Interior Evaluation :</b> <span style="float: right;"><b>B</b></span>	<b>Exterior Evaluation :</b> <span style="float: right;"><b>C</b></span>

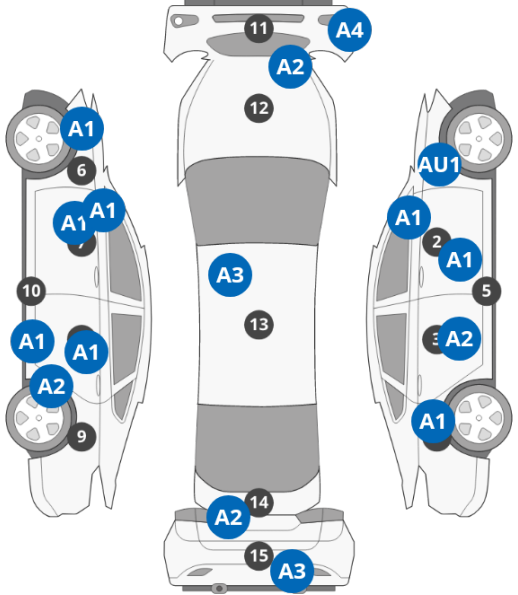
<p><b>A</b> : Scratch <b>AU</b> : Scratch &amp; Dent <b>B</b> : Modified <b>C</b> : Corrosion <b>G</b> : Stone chip <b>P</b> : Faded <b>S</b> : Rust <b>SC</b> : Rust &amp; Corrosion <b>U</b> : Dent <b>X</b> : Defective <b>Y</b> : Crack, Gap</p>
<p><b>Remarks</b> (R) Front Trim - Grime - Small / (L) Front Trim - Grime - Small / (L) Front Floor Mat - Worked - Small / (R) Front Floor Mat - Grime - Small / Ceiling - Grime - Minimal</p>	<p><b>Remarks</b> (R) Rear Fender - Repair Traces - Yes / (R) Front Fender, Molding - Scratch &amp; Dent - Minimal / (R) Mirror - Scratch - Minimal / (R) Front Door, Molding - Scratch - Minimal / (R) Rear Door, Molding - Scratch - Small / (R) Rear Fender, Molding - Scratch - Minimal / Rear Bumper, Lamps, Panels - Scratch - Medium / Trunk Hood, Rear Gate - Scratch - Small / (L) Rear Fender, Molding - Scratch - Small / (L) Step, In-panel, Side Spoiler - Scratch - Minimal / (L) Rear Door, Molding - Scratch - Minimal / (L) Front Door, Molding - Scratch - Minimal / (L) Mirror - Scratch - Minimal / (L) Front Fender, Molding - Scratch - Minimal / Front Bumper, Grille, Lamps - Scratch - Large / Bonnet, Headlight - Scratch - Small / Roof - Scratch - Medium</p>

<p><b>Inspector Notes</b></p>
<p>no warranty booklet, no jack and tools, with spare tire, with LTO plate, scratches on tail light</p>
