## General Information

<b>Make</b>	Toyota	<b>Model</b>	Innova
<b>YOM</b>	2016	<b>Odo Meter Reading</b>	87,677
<b>Registration No.</b>	NCZ3746	<b>Chassis No.</b>	PA2GA8EMXG0001057
<b>CC</b>	2.8	<b>Transmission</b>	A/T
<b>Fuel Type</b>	Diesel	<b>Type of Body</b>	Wagon
<b>Colour</b>	White

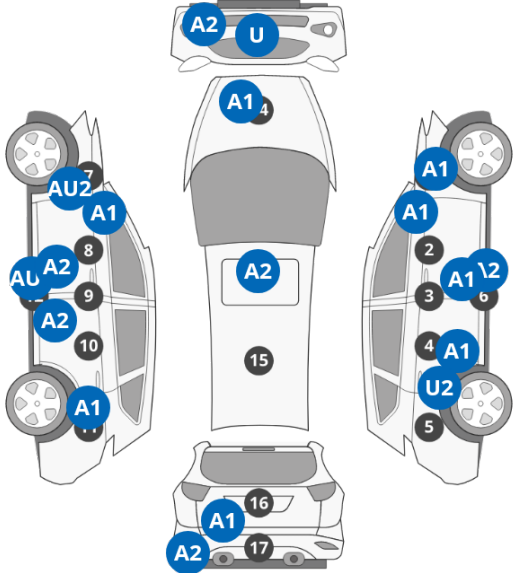
<p><b>A</b> : Scratch <b>AU</b> : Scratch &amp; Dent <b>B</b> : Modified <b>C</b> : Corrosion <b>G</b> : Stone chip <b>P</b> : Faded <b>S</b> : Rust <b>SC</b> : Rust &amp; Corrosion <b>U</b> : Dent <b>X</b> : Defective <b>Y</b> : Crack, Gap</p>
<p><b>Remarks</b> (R) Front Seat - Grime - Medium / (L) Front Seat - Worn - Yes / Overall Interior - Worn as per age - Yes / (R) Rear Trim - Grime - Minimal / (L) Rear Trim - Grime - Minimal / (L) Front Trim - Grime - Medium / (R) Front Trim - Grime - Medium / Ceiling - Grime - Small / Rear Seat - Grime - Medium</p>	<p><b>Remarks</b> (R) Front Door - Repair Traces - Yes / (R) Front Fender - Repair Traces - Yes / (R) Rear Fender - Repair Traces - Yes / (R) Rear Door - Repair Traces - Yes / Roof - Repair Traces - Yes / (R) Front Fender, Molding - Scratch - Minimal / (R) Step, In-panel, Side Spoiler - Scratch - Small / (R) Mirror - Scratch - Minimal / (R) Rear Door, Molding - Scratch - Minimal / (R) Front Door, Molding - Scratch - Minimal / (R) Rear Fender, Molding - Dent - Small / Rear Bumper, Lamps, Panels - Scratch - Small / Trunk Hood, Rear Gate - Scratch - Minimal / (L) Rear Fender, Molding - Scratch - Minimal / (L) Step, In-panel, Side Spoiler - Scratch &amp; Dent - Minimal / (L) Rear Door, Molding - Scratch - Small / (L) Front Door, Molding - Scratch - Small / (L) Mirror - Scratch - Minimal / (L) Front Fender, Molding - Scratch &amp; Dent - Small / Member (Bolted) - Dent - Yes / Front Bumper, Grille, Lamps - Scratch - Small / Bonnet, Headlight - Scratch - Minimal / Roof - Scratch - Small</p>
