General Information

Make	Toyota	Model	Vios
YOM	2024	Odo Meter Reading	3,222
Registration No.	NFS8947	Chassis No.	PA1B18F34R4243715
CC	1.3	Transmission	CVT
Fuel Type	Gas	Type of Body	Sedan
Colour	Green

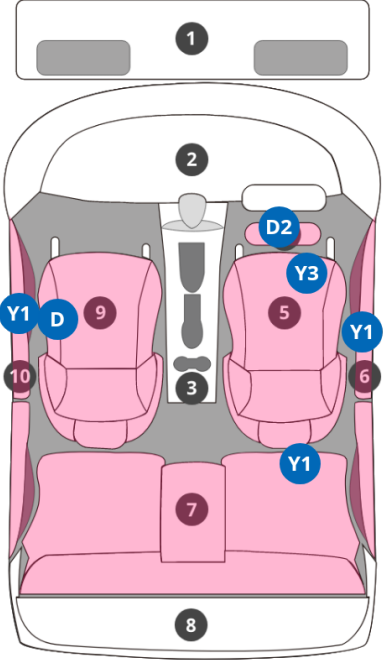
<p>A : Scratch AU : Scratch & Dent B : Modified C : Corrosion G : Stone chip P : Faded S : Rust SC : Rust & Corrosion U : Dent X : Defective Y : Crack, Gap</p>
<p>Remarks (R) Front Seat - Grime - Medium / (L) Front Seat - Worn - Yes / (R) Front Trim - Grime - Minimal / (L) Front Floor Mat - Worked - Small / (L) Front Trim - Grime - Minimal / Rear Seat - Grime - Minimal</p>	<p>Remarks (R) Front Door - Repair Traces - Yes / (R) Front Fender - Repair Traces - Yes / (L) Front Fender - Repair Traces - Yes / (R) Rear Door - Repair Traces - Yes / (R) Front Fender, Molding - Scratch - Minimal / (R) Mirror - Scratch - Minimal / (R) Front Door, Molding - Scratch - Small / (R) Step, In-panel, Side Spoiler - Scratch - Minimal / (R) Rear Door, Molding - Scratch - Minimal / (R) Rear Fender, Molding - Scratch - Minimal / Rear Bumper, Lamps, Panels - Scratch - Minimal / Trunk Hood, Rear Gate - Scratch - Medium / (L) Rear Fender, Molding - Scratch - Small / (L) Mirror - Scratch - Minimal / (L) Rear Door, Molding - Scratch - Small / (L) Front Door, Molding - Scratch - Small / (L) Front Fender, Molding - Scratch - Minimal / Front Bumper, Grille, Lamps - Scratch - Small / Bonnet, Headlight - Scratch - Minimal / Roof - Scratch & Dent - Large</p>
