## General Information

<b>Make</b>	Toyota	<b>Model</b>	Vios
<b>YOM</b>	2024	<b>Odo Meter Reading</b>	20,217
<b>Registration No.</b>	DBN8961	<b>Chassis No.</b>	PA1B18F39P4234618
<b>CC</b>	1.3	<b>Transmission</b>	CVT
<b>Fuel Type</b>	Gas	<b>Type of Body</b>	Sedan
<b>Colour</b>	Black

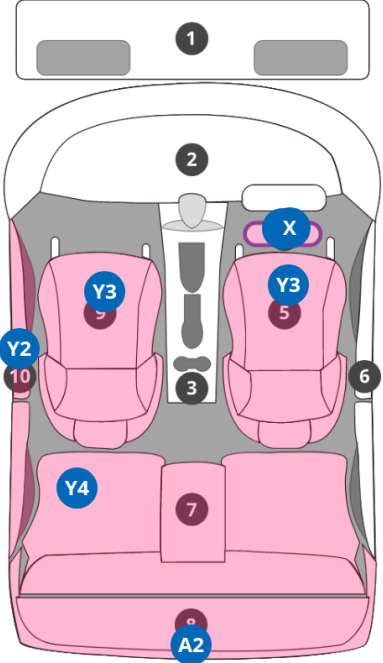
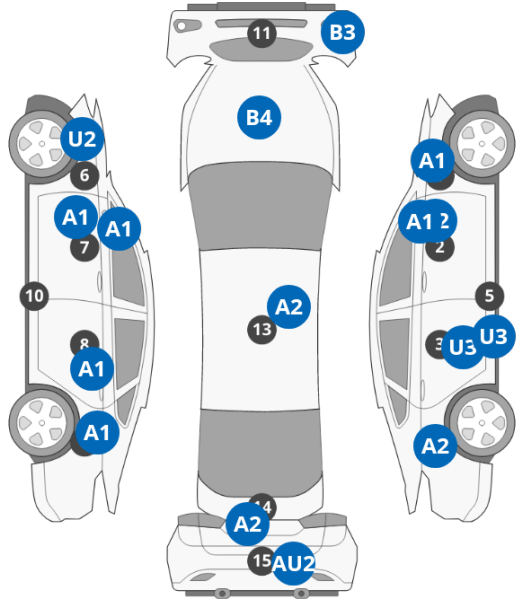
<b>Interior Evaluation :</b>	C	<b>Exterior Evaluation :</b>	D

<p><b>a</b> : Cut, Fray <b>d</b> : Loose, Deformed <b>k</b> : Animal Hair <b>s</b> : Smell <b>t</b> : Cigarette Burns <b>x</b> : Defective <b>y</b> : Stain</p>		<p><b>A</b> : Scratch <b>AU</b> : Scratch &amp; Dent <b>B</b> : Modified <b>C</b> : Corrosion <b>G</b> : Stone chip <b>P</b> : Faded <b>S</b> : Rust <b>SC</b> : Rust &amp; Corrosion <b>U</b> : Dent <b>X</b> : Defective <b>Y</b> : Crack, Gap</p>	
<p><b>Remarks</b> (L) Front Floor Mat - Missing - Yes / (R) Front Floor Mat - Missing - Yes / (R) Front Seat - Grime - Medium / Rear Seat - Grime - Large / (L) Front Seat - Grime - Medium / (L) Front Trim - Grime - Small / Trunk Room - Worn, Scratch, Cut, Crack - Small</p>		<p><b>Remarks</b> Bonnet, Headlight - Modified - Large / Front Bumper, Grille, Lamps - Modified - Medium / (R) Front Door, Molding - Scratch - Small / (R) Rear Door, Molding - Dent - Medium / (R) Step, In-panel, Side Spoiler - Dent - Medium / (R) Rear Fender, Molding - Scratch - Small / Rear Bumper, Lamps, Panels - Scratch &amp; Dent - Small / Trunk Hood, Rear Gate - Scratch - Small / (L) Rear Fender, Molding - Scratch - Minimal / (L) Rear Door, Molding - Scratch - Minimal / Roof - Scratch - Small / (L) Front Door, Molding - Scratch - Minimal / (L) Front Fender, Molding - Dent - Small / (R) Front Fender, Molding - Scratch - Minimal / (R) Mirror - Scratch - Minimal / (L) Mirror - Scratch - Minimal</p>
