General Information

Date & Time: 10, Sep, 2025 09:00

Make	Toyota	Model	Lite Ace
YOM	2023	Odo Meter Reading	32,332
Registration No.	EAG3845	Chassis No.	MHKU3FE10NK002410
CC	1.5	Transmission	M/T
Fuel Type	Gas	Type of Body	Pickup
Colour	White

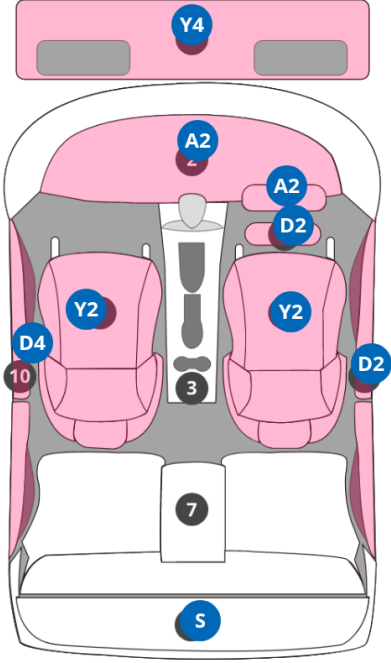
Interior Evaluation : C	Exterior Evaluation : E

<p>A : Scratch AU : Scratch & Dent B : Modified C : Corrosion G : Stone chip P : Faded S : Rust SC : Rust & Corrosion U : Dent X : Defective Y : Crack, Gap</p>
<p>Remarks Ceiling - Grime - Large / (R) Front Trim - Worked - Small / Overall Interior - Smell - Yes / Dashboard - Worn, Scratch, Cut, Crack - Small / Glove Box - Worn, Scratch, Cut, Crack - Small / Mat Other - Worked - Small / (L) Front Trim - Worked - Large / (L) Front Seat - Grime - Small / (R) Front Seat - Grime - Small</p>	<p>Remarks Cargo Bed Floor - Rust, Corrosion - Large / Rear Gate - Scratch & Dent - Large / (R) Side Gate - Scratch - Large / (L) Side Gate - Scratch - Medium / (L) Front Door, Molding - Scratch - Medium / (L) Front Fender, Molding - Rust, Corrosion - Medium / (R) Front Door, Molding - Scratch - Large / Roof - Dent - Large / Front Panel - Scratch - Medium / (L) Mirror - Scratch - Minimal / (R) Mirror - Scratch - Minimal / Front Bumper, Grille, Lamps - Scratch - Large</p>

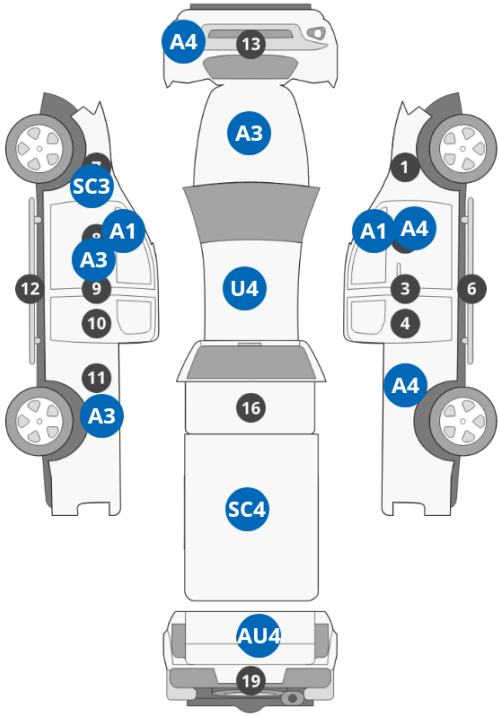
<p>Inspector Notes</p>
<p>with LTO plate, no warranty booklet, no jack and tools, with spare tire, damaged tail light and headlights</p>
