General Information

Make	Toyota	Model	Wigo
YOM	2023	Odo Meter Reading	34,646
Registration No.	NHJ4230	Chassis No.	MHKA4DEPJ018316
CC	1.0	Transmission	M/T
Fuel Type	Gas	Type of Body	Hatchback
Colour	Silver

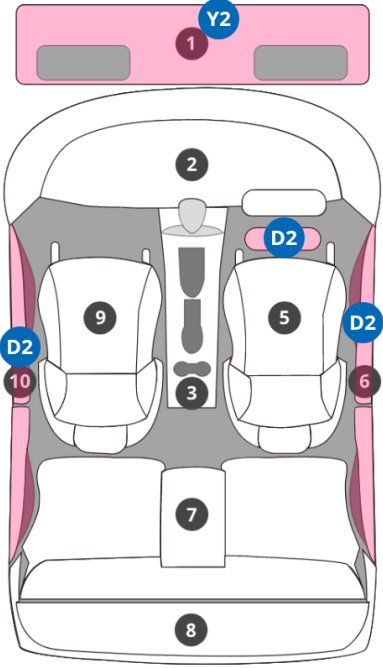
Interior Evaluation : A	Exterior Evaluation : D

<p>a : Cut, Fray d : Loose, Deformed k : Animal Hair s : Smell t : Cigarette Burns x : Defective y : Stain</p>

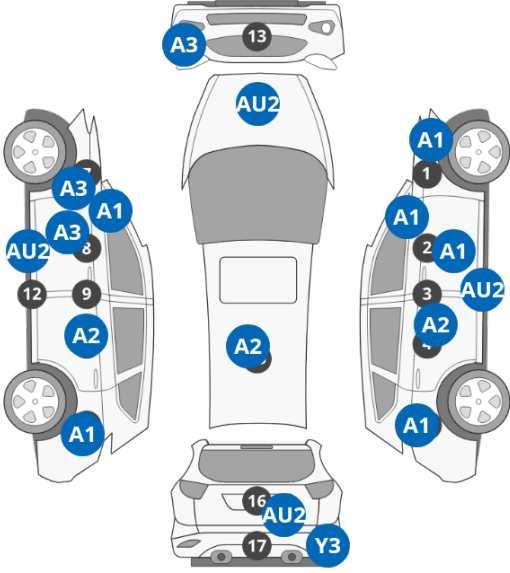
<p>A : Scratch AU : Scratch & Dent B : Modified C : Corrosion G : Stone chip P : Faded S : Rust SC : Rust & Corrosion U : Dent X : Defective Y : Crack, Gap</p>
<p>Remarks (L) Front Floor Mat - Worked - Small / (L) Front Trim - Worked - Small / (R) Front Trim - Worked - Small / Ceiling - Grime - Small</p>	<p>Remarks (R) Front Door - Repair Traces - Yes / (R) Front Fender - Repair Traces - Yes / Bonnet - Repair Traces - Yes / (L) Front Fender - Repair Traces - Yes / (L) Front Door - Repair Traces - Yes / (L) Rear Door - Repair Traces - Yes / (L) Rear Fender - Repair Traces - Yes / Trunk Hood, Rear Gate - Repair Traces - Yes / (R) Rear Fender - Repair Traces - Yes / (R) Rear Door - Repair Traces - Yes / Roof - Repair Traces - Yes / (L) Front Fender, Molding - Scratch - Medium / (L) Front Door, Molding - Scratch - Medium / (L) Step, In-panel, Side Spoiler - Scratch & Dent - Small / (L) Rear Door, Molding - Scratch - Small / (L) Rear Fender, Molding - Scratch - Minimal / (L) Mirror - Scratch - Minimal / Front Bumper, Grille, Lamps - Scratch - Medium / (R) Front Fender, Molding - Scratch - Minimal / (R) Mirror - Scratch - Minimal / (R) Front Door, Molding - Scratch - Minimal / (R) Rear Door, Molding - Scratch - Small / (R) Step, In-panel, Side Spoiler - Scratch & Dent - Small / (R) Rear Fender, Molding - Scratch - Minimal / Rear Bumper, Lamps, Panels - Crack, Gap - Medium / Trunk Hood, Rear Gate - Scratch & Dent - Small / Roof - Scratch - Small / Bonnet, Headlight - Scratch & Dent - Small</p>
