## General Information

| Make | Toyota | Model | Wigo |
| YOM | 2023 | Mileage | 21,161 |
| Registration No. | DBG8637 | Chassis No. | MHKA4DF5FNJ078657 |

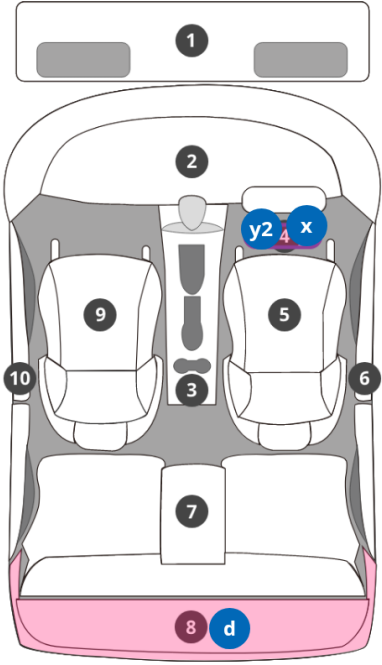
| Interior Evaluation : <b>B</b> | Exterior Evaluation : <b>C</b> |
|---|---|
| <b>Remarks</b><br>(L) Front Floor Mat - Grime - Small / Trunk Room - Traces of Adhesive Tape - Yes / Mat Other - Missing - Yes | <b>Remarks</b><br>Bonnet - Repair Traces - Yes / Front Bumper, Grille, Lamps - Crack, Gap - Large / (R) Step, In-panel, Side Spoiler - Scratch & Dent - Medium / (L) Mirror - Scratch - Minimal / Bonnet, Headlight - Scratch - Medium |

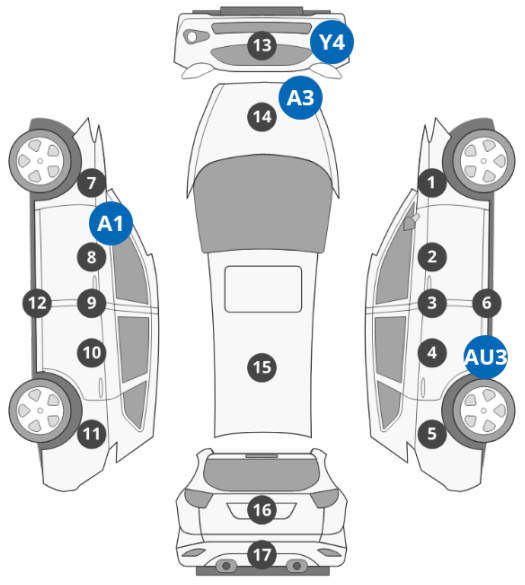
hairline scratches around the exterior. no warranty booklet, user manual and tools.
