## General Information

Date & Time: 06, Sep, 2025 11:05

<b>Make</b>	Toyota	<b>Model</b>	Wigo
<b>YOM</b>	2024	<b>Odo Meter Reading</b>	14,278
<b>Registration No.</b>	CCC5077	<b>Chassis No.</b>	MHKAA1BCPJ009906
<b>CC</b>	1.0	<b>Transmission</b>	CVT
<b>Fuel Type</b>	Gas	<b>Type of Body</b>	Hatchback
<b>Colour</b>	Yellow

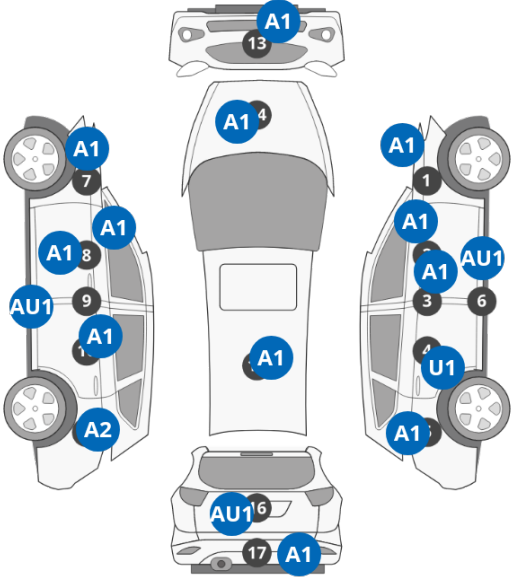
<p><b>A</b> : Scratch <b>AU</b> : Scratch &amp; Dent <b>B</b> : Modified <b>C</b> : Corrosion <b>G</b> : Stone chip <b>P</b> : Faded <b>S</b> : Rust <b>SC</b> : Rust &amp; Corrosion <b>U</b> : Dent <b>X</b> : Defective <b>Y</b> : Crack, Gap</p>
<b>Remarks</b> Defects not found	<b>Remarks</b> (L) Front Door, Molding - Scratch - Minimal / Front Bumper, Grille, Lamps - Scratch - Minimal / (L) Mirror - Scratch - Minimal / (R) Mirror - Scratch - Minimal / (R) Front Door, Molding - Scratch - Minimal / (R) Rear Door, Molding - Dent - Minimal / (R) Step, In-panel, Side Spoiler - Scratch & Dent - Minimal / (L) Step, In-panel, Side Spoiler - Scratch & Dent - Minimal / (R) Rear Fender, Molding - Scratch - Minimal / Rear Bumper, Lamps, Panels - Scratch - Minimal / Roof - Scratch - Minimal / Bonnet, Headlight - Scratch - Minimal / (L) Rear Door, Molding - Scratch - Minimal / (L) Rear Fender, Molding - Scratch - Small / Trunk Hood, Rear Gate - Scratch & Dent - Minimal / (R) Front Fender, Molding - Scratch - Minimal / (L) Front Fender, Molding - Scratch - Minimal

<b>Inspector Notes</b>
With LTO plate and Sparetire and Jack and Incomplete Tools, No warranty booklet and scratch headlight and tail. adhesive marks on Side mirror.
