## General Information

<b>Make</b>	Toyota	<b>Model</b>	Alphard
<b>YOM</b>	2020	<b>Odo Meter Reading</b>	9,972
<b>Registration No.</b>	NEL1771	<b>Chassis No.</b>	JNTNGZ3D5LL8031030
<b>CC</b>	3.5	<b>Transmission</b>	A/T
<b>Fuel Type</b>	Gas	<b>Type of Body</b>	Van
<b>Colour</b>	White

## Body / Panel Condition

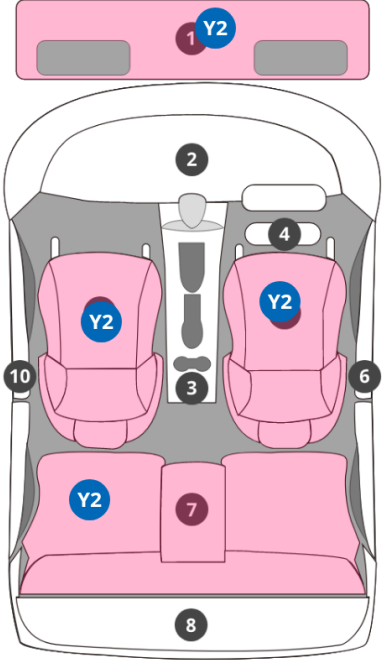
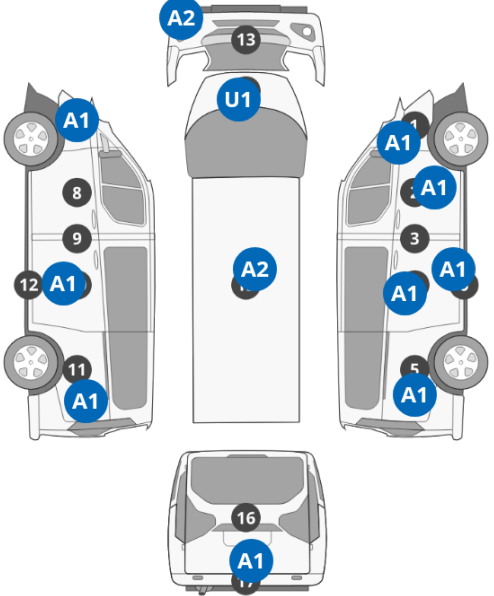
<p><b>a</b> : Cut, Fray <b>d</b> : Loose, Deformed <b>k</b> : Animal Hair <b>s</b> : Smell <b>t</b> : Cigarette Burns <b>x</b> : Defective <b>y</b> : Stain</p>		<p><b>A</b> : Scratch <b>AU</b> : Scratch &amp; Dent <b>B</b> : Modified <b>C</b> : Corrosion <b>G</b> : Stone chip <b>P</b> : Faded <b>S</b> : Rust <b>SC</b> : Rust &amp; Corrosion <b>U</b> : Dent <b>X</b> : Defective <b>Y</b> : Crack, Gap</p>	
<p><b>Remarks</b> (L) Front Seat - Grime - Small / (R) Front Seat - Grime - Small / Rear Seat - Grime - Small / Ceiling - Grime - Small</p>		<p><b>Remarks</b> (L) Rear Fender, Molding - Scratch - Minimal / (L) Rear Door, Molding - Scratch - Minimal / (L) Front Fender, Molding - Scratch - Minimal / Front Bumper, Grille, Lamps - Scratch - Small / (R) Step, In-panel, Side Spoiler - Scratch - Minimal / (R) Rear Door, Molding - Scratch - Minimal / (R) Front Door, Molding - Scratch - Minimal / (R) Front Fender, Molding - Scratch - Minimal / (R) Rear Fender, Molding - Scratch - Minimal / Trunk Hood, Rear Gate - Scratch - Minimal / Roof - Scratch - Small / Bonnet, Headlight - Dent - Minimal</p>

<b>Inspector Notes</b>
<p>With LTO plate and warranty booklet and Sparetire and, Incomplete Tools, No Jack and scratch headlight and tail light. double registration under two records.</p>
