## General Information

<b>Make</b>	Toyota	<b>Model</b>	Vios
<b>YOM</b>	2024	<b>Odo Meter Reading</b>	34,841
<b>Registration No.</b>	NKB3059	<b>Chassis No.</b>	PA1B18F31R47544
<b>CC</b>	1.3	<b>Transmission</b>	CVT
<b>Fuel Type</b>	Gas	<b>Type of Body</b>	Sedan
<b>Colour</b>	Blue

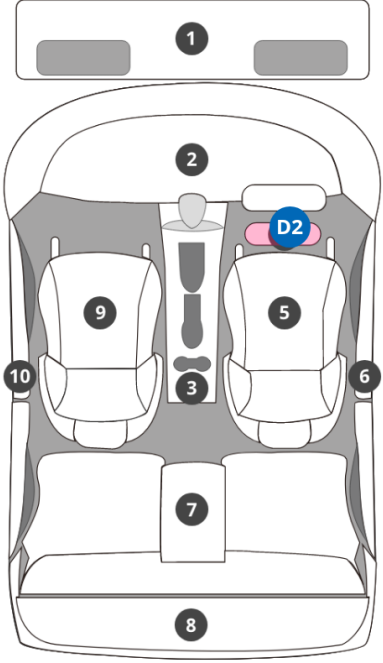
<p><b>a</b> : Cut, Fray <b>d</b> : Loose, Deformed <b>k</b> : Animal Hair <b>s</b> : Smell <b>t</b> : Cigarette Burns <b>x</b> : Defective <b>y</b> : Stain</p>

<p><b>A</b> : Scratch <b>AU</b> : Scratch &amp; Dent <b>B</b> : Modified <b>C</b> : Corrosion <b>G</b> : Stone chip <b>P</b> : Faded <b>S</b> : Rust <b>SC</b> : Rust &amp; Corrosion <b>U</b> : Dent <b>X</b> : Defective <b>Y</b> : Crack, Gap</p>
<b>Remarks</b> (L) Front Floor Mat - Worked - Small	<b>Remarks</b> Trunk Hood, Rear Gate - Scratch & Dent - Medium / Rear Bumper, Lamps, Panels - Crack, Gap - Large / (L) Rear Fender, Molding - Scratch - Small / (L) Front Door, Molding - Scratch - Small / (L) Front Fender, Molding - Scratch - Minimal / (L) Mirror - Scratch - Minimal / (L) Step, In-panel, Side Spoiler - Scratch & Dent - Small / (L) Rear Door, Molding - Scratch - Small / Member (Bolted) - Dent - Yes / Front Bumper, Grille, Lamps - Scratch - Small / (R) Mirror - Scratch - Minimal / (R) Front Fender, Molding - Scratch - Minimal / (R) Front Door, Molding - Scratch - Small / (R) Rear Door, Molding - Scratch & Dent - Minimal / (R) Step, In-panel, Side Spoiler - Scratch & Dent - Minimal / (R) Rear Fender, Molding - Dent - Small / Roof - Scratch - Small / Bonnet, Headlight - Scratch & Dent - Small
