## General Information

| <b>Make</b> | Hino | <b>Model</b> | XZU710LN |
| <b>Registration No.</b> | CCJ7119 | <b>Chassis No.</b> | JHHUCP3F3SK059419 |

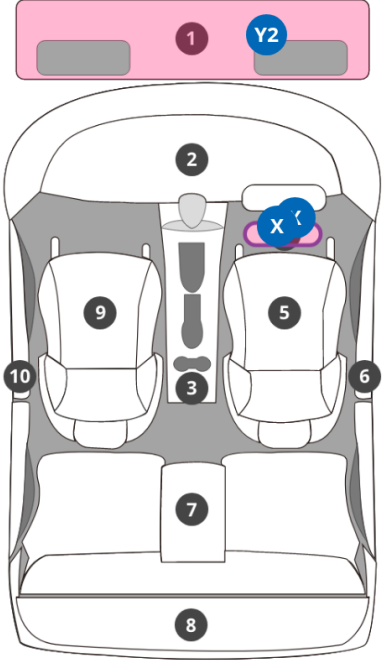
| <b>Interior Evaluation :</b> <span style="float: right;"><b>B</b></span> | <b>Exterior Evaluation :</b> <span style="float: right;"><b>C</b></span> |
| <p><b>Remarks</b><br/>(L) Front Floor Mat - Missing - Yes / (R) Front Floor Mat - Missing - Yes / Ceiling - Grime - Small</p> | <p><b>Remarks</b><br/>(L) Front Door, Molding - Scratch - Small / (L) Side Gate - Scratch - Medium / (R) Side Gate - Scratch &amp; Dent - Medium / Front Panel - Scratch - Minimal / Front Bumper, Grille, Lamps - Scratch - Small / Roof - Scratch - Small / (L) Front Fender, Molding - Scratch - Minimal / (R) Front Fender, Molding - Scratch - Minimal / (R) Front Door, Molding - Scratch - Small / Rear Gate - Scratch - Small / Rear Bumper, Lamps, Panels - Scratch - Small</p> |
