General Information

Date & Time: 02, Mar, 2026 17:49

Make	Toyota	Model	Hilux
YOM	2014	Odo Meter Reading	268,956
Registration No.	AAC9646	Chassis No.	MR0FZ29G802532422
CC	2.4	Transmission	A/T
Fuel Type	Diesel	Type of Body	Pickup
Colour	Black

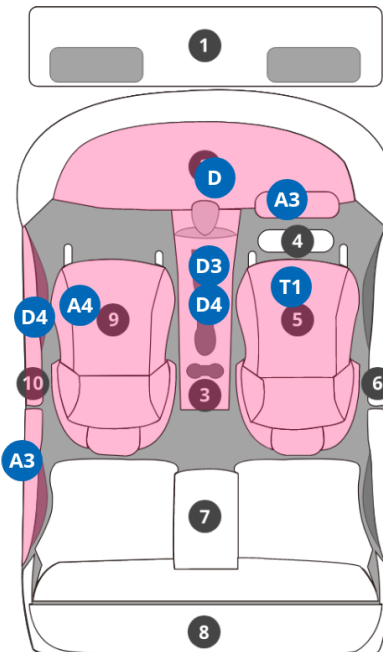
Interior Evaluation : D	Exterior Evaluation : E

<p>a : Cut, Fray d : Loose, Deformed k : Animal Hair s : Smell t : Cigarette Burns x : Defective y : Stain</p>

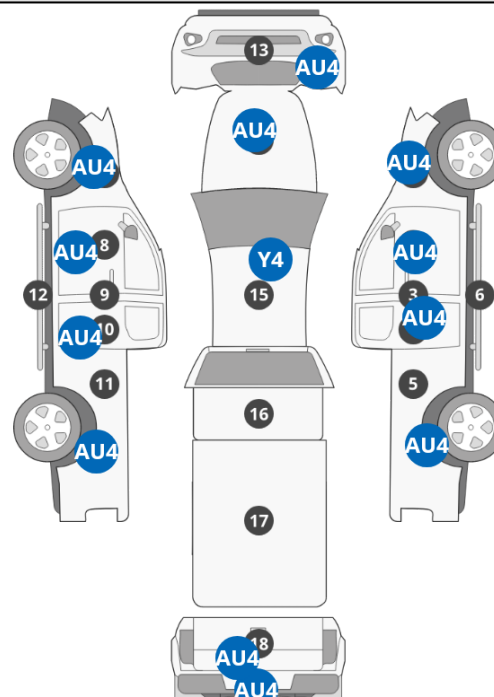
<p>A : Scratch AU : Scratch & Dent B : Modified C : Corrosion G : Stone chip P : Faded S : Rust SC : Rust & Corrosion U : Dent X : Defective Y : Crack, Gap</p>
<p>Remarks Overall Interior - Worn as per age - Yes / (L) Front Seat - Cut, Crack - Large / Dashboard - Traces of Adhesive Tape - Yes / (L) Rear Trim - Cut, Crack - Medium / (L) Front Trim - Worked - Large / Console, Switches, Vents - Loose, Deformed - Medium / (R) Front Seat - Cigarette Burns - Burnt Minimal / Console, Switches, Vents - Worked - Large / Glove Box - Worn, Scratch, Cut, Crack - Medium</p>	<p>Remarks (R) Step - Repair Traces - Yes / (R) Front Fender - Repair Traces - Yes / Bonnet - Repair Traces - Yes / (L) Front Fender - Repair Traces - Yes / (L) Step - Repair Traces - Yes / Rear Bumper, Lamps, Panels - Scratch & Dent - Large / Rear Gate - Scratch & Dent - Large / (L) Side Gate - Scratch & Dent - Large / (L) Rear Door, Molding - Scratch & Dent - Large / (L) Front Door, Molding - Scratch & Dent - Large / (L) Front Fender, Molding - Scratch & Dent - Large / Front Bumper, Grille, Lamps - Scratch & Dent - Large / Bonnet, Headlight - Scratch & Dent - Large / (R) Front Fender, Molding - Scratch & Dent - Large / (R) Front Door, Molding - Scratch & Dent - Large / (R) Rear Door, Molding - Scratch & Dent - Large / (R) Side Gate - Scratch & Dent - Large / Overall Exterior - Faded(Color, Gloss) - Yes / Overall Exterior - Worn as per age - Yes / Front Windshield - Damaged - Large</p>
