## General Information

Date & Time: 10, Sep, 2025 15:45

<b>Make</b>	Toyota	<b>Model</b>	Wigo
<b>YOM</b>	2024	<b>Odo Meter Reading</b>	22,804
<b>Registration No.</b>	DBQ4197	<b>Chassis No.</b>	MHKAA1BC7RJ020581
<b>CC</b>	1.0	<b>Transmission</b>	CVT
<b>Fuel Type</b>	Gas	<b>Type of Body</b>	Hatchback
<b>Colour</b>	Silver

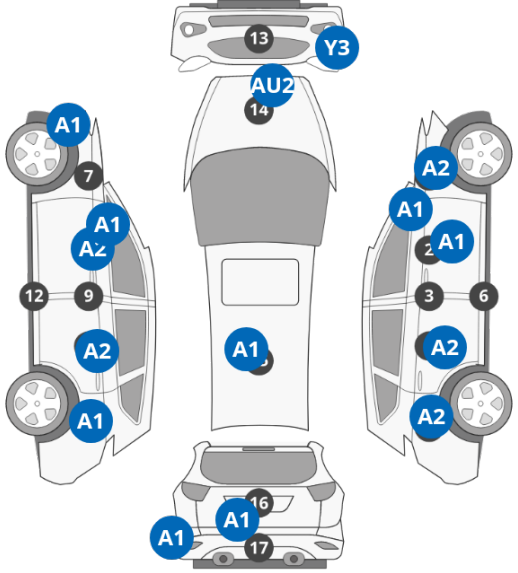
<p><b>A</b> : Scratch <b>AU</b> : Scratch &amp; Dent <b>B</b> : Modified <b>C</b> : Corrosion <b>G</b> : Stone chip <b>P</b> : Faded <b>S</b> : Rust <b>SC</b> : Rust &amp; Corrosion <b>U</b> : Dent <b>X</b> : Defective <b>Y</b> : Crack, Gap</p>
<b>Remarks</b> Rear Seat - Grime - Medium / Ceiling - Grime - Minimal / (L) Front Floor Mat - Worked - Small	<b>Remarks</b> (R) Front Door - Repair Traces - Yes / Bonnet - Repair Traces - Yes / (L) Front Fender - Repair Traces - Yes / (L) Front Door - Repair Traces - Yes / (L) Rear Door - Repair Traces - Yes / (R) Rear Door - Repair Traces - Yes / (R) Front Fender, Molding - Scratch - Small / (R) Mirror - Scratch - Minimal / (R) Front Door, Molding - Scratch - Minimal / (R) Rear Door, Molding - Scratch - Small / (R) Rear Fender, Molding - Scratch - Small / Rear Bumper, Lamps, Panels - Scratch - Minimal / Trunk Hood, Rear Gate - Scratch - Minimal / (L) Rear Fender, Molding - Scratch - Minimal / (L) Rear Door, Molding - Scratch - Small / (L) Front Door, Molding - Scratch - Small / (L) Mirror - Scratch - Minimal / (L) Front Fender, Molding - Scratch - Minimal / Front Bumper, Grille, Lamps - Crack, Gap - Medium / Bonnet, Headlight - Scratch & Dent - Small / Roof - Scratch - Minimal / Overall Exterior - Full Re-Paint in same color - Yes
