## General Information

Date & Time: 10, Sep, 2025 14:50

Make	Suzuki	Model	Dzire
YOM	2024	Odo Meter Reading	33,953
Registration No.	NKA6767	Chassis No.	MBHZF63S2RG481972
CC	1.2	Transmission	A/T
Fuel Type	Gas	Type of Body	Sedan
Colour	Red

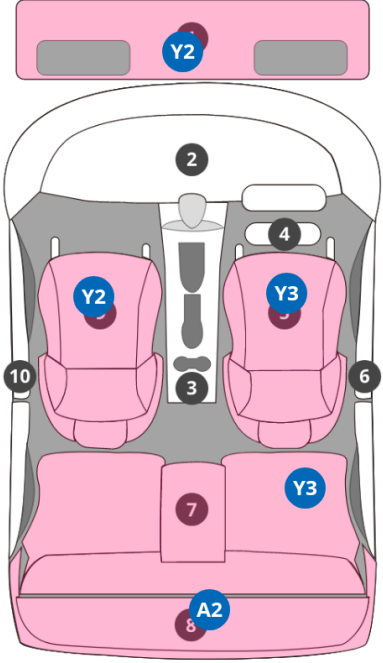
<b>Interior Evaluation :</b> <span style="float: right; color: red; font-weight: bold;">B</span>	<b>Exterior Evaluation :</b> <span style="float: right; color: red; font-weight: bold;">D</span>

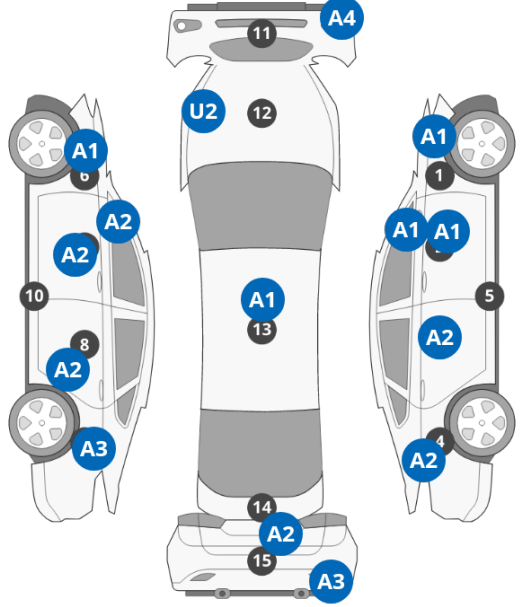
<p><b>A</b> : Scratch <b>AU</b> : Scratch &amp; Dent <b>B</b> : Modified <b>C</b> : Corrosion <b>G</b> : Stone chip <b>P</b> : Faded <b>S</b> : Rust <b>SC</b> : Rust &amp; Corrosion <b>U</b> : Dent <b>X</b> : Defective <b>Y</b> : Crack, Gap</p>
<p><b>Remarks</b> Trunk Room - Worn, Scratch, Cut, Crack - Small / Rear Seat - Grime - Medium / (R) Front Seat - Grime - Medium / Ceiling - Grime - Small / (L) Front Seat - Grime - Small</p>	<p><b>Remarks</b> (R) Front Fender, Molding - Scratch - Minimal / (R) Mirror - Scratch - Minimal / (R) Front Door, Molding - Scratch - Minimal / (R) Rear Door, Molding - Scratch - Small / (R) Rear Fender, Molding - Scratch - Small / Rear Bumper, Lamps, Panels - Scratch - Medium / Trunk Hood, Rear Gate - Scratch - Small / (L) Rear Fender, Molding - Scratch - Medium / (L) Rear Door, Molding - Scratch - Small / (L) Mirror - Scratch - Small / (L) Front Door, Molding - Scratch - Small / (L) Front Fender, Molding - Scratch - Minimal / Front Bumper, Grille, Lamps - Scratch - Large / Roof - Scratch - Minimal / Bonnet, Headlight - Dent - Small</p>

<p><b>Inspector Notes</b></p>
<p>with LTO plate, no warranty booklet, with jack and incomplete tools, with spare tire, scratches on headlight and tail light</p>
