General Information

Make	Mitsubishi	Model	L300
YOM	2015	Odo Meter Reading	197,580
Registration No.	ABL2872	Chassis No.	PAEL65MYFFB016523
CC	2.5	Transmission	M/T
Fuel Type	Diesel	Type of Body	Commercial Vehicles
Colour	White

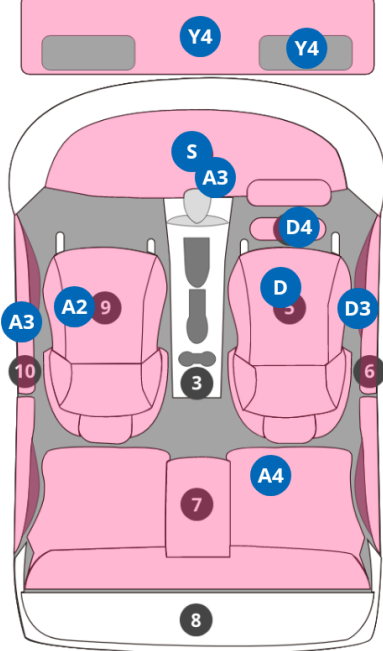
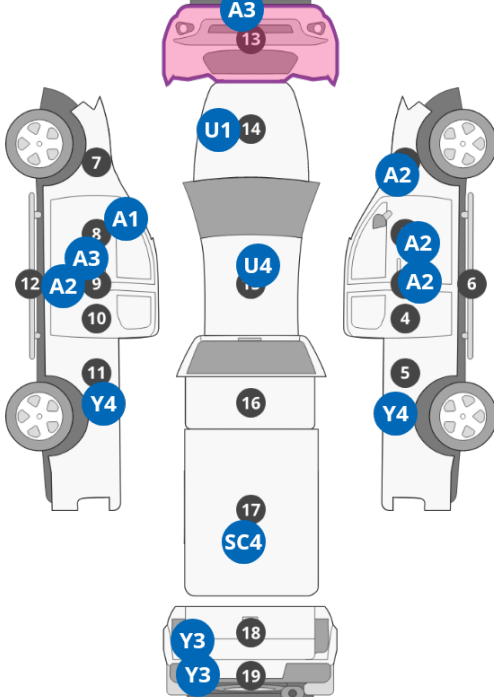
Interior Evaluation :	E	Exterior Evaluation :	E

<p>a : Cut, Fray d : Loose, Deformed k : Animal Hair s : Smell t : Cigarette Burns x : Defective y : Stain</p>		<p>A : Scratch AU : Scratch & Dent B : Modified C : Corrosion G : Stone chip P : Faded S : Rust SC : Rust & Corrosion U : Dent X : Defective Y : Crack, Gap</p>	
<p>Remarks Overall Interior - Worn as per age - Yes / Overall Interior - Smell - Yes / Rear Seat - Cut, Crack - Large / Ceiling - Grime - Large / Carpet - Worked - Large / (R) Front Trim - Loose, Deformed - Medium / (R) Front Seat - Worn - Yes / (L) Front Seat - Cut, Crack - Small / Sunvisor, Sunglass Holder - Grime - Large / Dashboard - Worn, Scratch, Cut, Crack - Medium / (L) Front Trim - Cut, Crack - Medium</p>		<p>Remarks (R) Front Door - Repair Traces - Yes / Front Panel - Repair Traces - Yes / (L) Rear Corner Panel - Repair Traces - Yes / (R) Rear Corner Panel - Repair Traces - Yes / Roof - Repair Traces - Yes / (R) Front Fender, Molding - Scratch - Small / (R) Front Door, Molding - Scratch - Small / (R) Center Panel - Scratch - Small / (R) Side Gate - Crack, Gap - Large / Cargo Bed Floor - Rust, Corrosion - Large / Rear Gate - Crack, Gap - Medium / Rear Bumper, Lamps, Panels - Crack, Gap - Medium / (L) Side Gate - Crack, Gap - Large / (L) Front Door, Molding - Scratch - Medium / (L) Center Panel - Scratch - Small / (L) Mirror - Scratch - Minimal / Front Bumper, Grille, Lamps - Repair mark - Yes / Front Bumper, Grille, Lamps - Scratch - Medium / Front Panel - Dent - Minimal / Roof - Dent - Large / Overall Exterior - Worn as per age - Yes</p>
