## General Information

Make	MG	Model	MG 5
YOM	2022	Odo Meter Reading	40,209
Registration No.	LAK8037	Chassis No.	LSJA36E38NZ017924
CC	1.5	Transmission	M/T
Fuel Type	Gas	Type of Body	Sedan
Colour	White

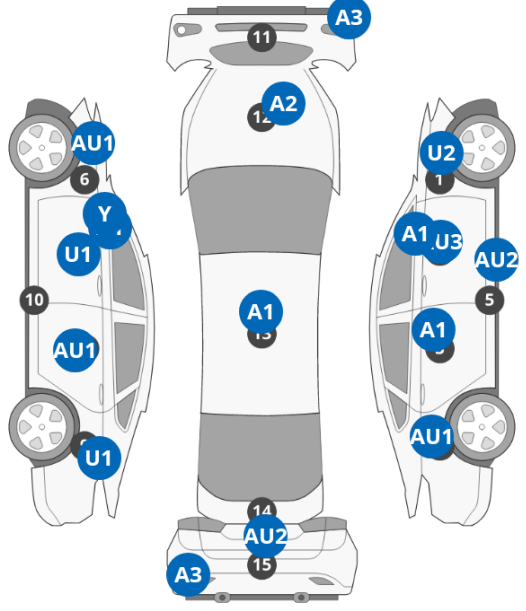
<p><b>A</b> : Scratch <b>AU</b> : Scratch &amp; Dent <b>B</b> : Modified <b>C</b> : Corrosion <b>G</b> : Stone chip <b>P</b> : Faded <b>S</b> : Rust <b>SC</b> : Rust &amp; Corrosion <b>U</b> : Dent <b>X</b> : Defective <b>Y</b> : Crack, Gap</p>
<p><b>Remarks</b> Rear Seat - Grime - Small / Ceiling - Grime - Small / Overall Interior - Smell - Yes / (L) Front Floor Mat - Worked - Small / (R) Front Floor Mat - Worked - Small / Mat Other - Worked - Small</p>	<p><b>Remarks</b> (L) Mirror - Scratch - Minimal / (L) Mirror - Crack - Damaged / (L) Rear Door, Molding - Scratch &amp; Dent - Minimal / (L) Front Door, Molding - Dent - Minimal / Front Bumper, Grille, Lamps - Scratch - Medium / (R) Front Fender, Molding - Dent - Small / (R) Front Door, Molding - Scratch &amp; Dent - Medium / (R) Step, In-panel, Side Spoiler - Scratch &amp; Dent - Small / (R) Rear Door, Molding - Scratch - Minimal / (R) Rear Fender, Molding - Scratch &amp; Dent - Minimal / Rear Bumper, Lamps, Panels - Scratch - Medium / (L) Rear Fender, Molding - Dent - Minimal / Trunk Hood, Rear Gate - Scratch &amp; Dent - Small / Roof - Scratch - Minimal / (R) Mirror - Scratch - Minimal / Bonnet, Headlight - Scratch - Small / (L) Front Fender, Molding - Scratch &amp; Dent - Minimal</p>
