General Information

Make	Mitsubishi	Model	Mirage
YOM	2023	Odo Meter Reading	13,793
Registration No.	DBH6951	Chassis No.	PAEA123TJPPA008177
CC	1.2	Transmission	CVT
Fuel Type	Gas	Type of Body	Sedan
Colour	Silver

Body / Panel Condition

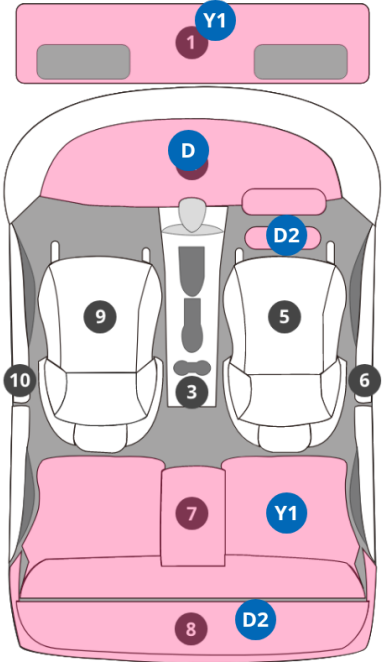
Interior Evaluation : A	Exterior Evaluation : C

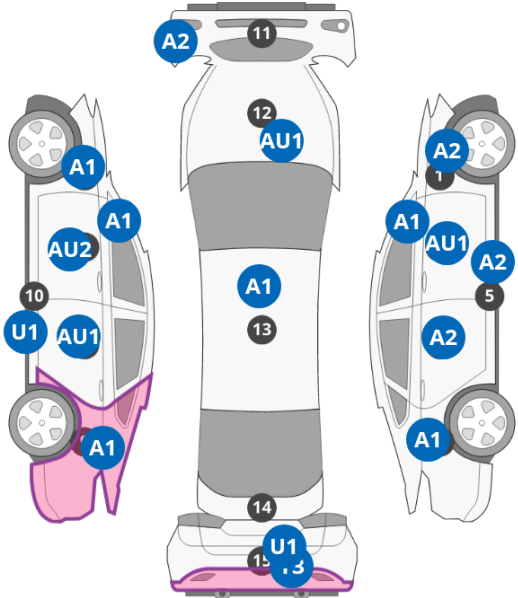
<p>A : Scratch AU : Scratch & Dent B : Modified C : Corrosion G : Stone chip P : Faded S : Rust SC : Rust & Corrosion U : Dent X : Defective Y : Crack, Gap</p>
<p>Remarks Ceiling - Grime - Minimal / (L) Front Floor Mat - Worked - Small / Rear Seat - Grime - Minimal / Dashboard - Traces of Adhesive Tape - Yes / Trunk Room - Loose, Deformed - Small</p>	<p>Remarks (L) Rear Fender - Repair Traces - Yes / Rear Bumper, Lamps, Panels - Repair mark - Yes / Rear Bumper, Lamps, Panels - Crack, Gap - Medium / (L) Rear Fender, Molding - Repair mark - Yes / Trunk Hood, Rear Gate - Dent - Minimal / (L) Rear Fender, Molding - Scratch - Minimal / (L) Rear Door, Molding - Scratch & Dent - Minimal / (L) Front Door, Molding - Scratch & Dent - Small / (L) Step, In-panel, Side Spoiler - Dent - Minimal / (L) Front Fender, Molding - Scratch - Minimal / (L) Mirror - Scratch - Minimal / Front Bumper, Grille, Lamps - Scratch - Small / Bonnet, Headlight - Scratch & Dent - Minimal / (R) Front Fender, Molding - Scratch - Small / (R) Front Door, Molding - Scratch & Dent - Minimal / (R) Rear Door, Molding - Scratch - Small / (R) Step, In-panel, Side Spoiler - Scratch - Small / (R) Mirror - Scratch - Minimal / (R) Rear Fender, Molding - Scratch - Minimal / Roof - Scratch - Minimal</p>
