## General Information

| Make | Toyota | Model | Vios |
| Registration No. | FAQ4010 | Chassis No. | PA1B18F39P4232450 |

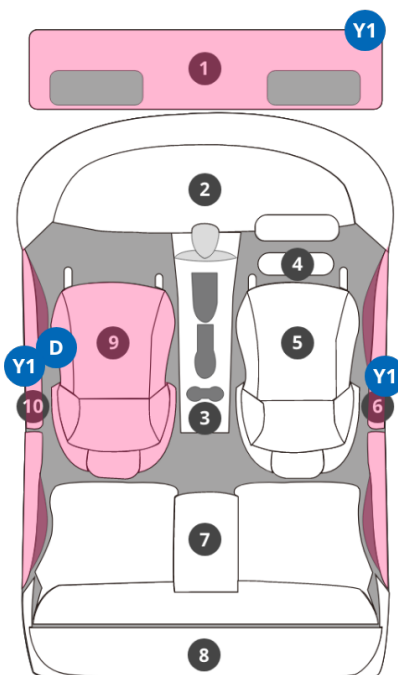
| Interior Evaluation : <b>B</b> | Exterior Evaluation : <b>B</b> |
|---|---|
| <p><b>Remarks</b><br/>(L) Front Seat - Worn - Yes / (R) Front Trim - Grime - Minimal / (L) Front Trim - Grime - Minimal / Ceiling - Grime - Minimal</p> | <p><b>Remarks</b><br/>(R) Front Fender, Molding - Scratch - Minimal / (R) Mirror - Scratch - Minimal / (R) Front Door, Molding - Scratch - Minimal / (R) Rear Door, Molding - Scratch - Minimal / Rear Bumper, Lamps, Panels - Scratch &amp; Dent - Small / Trunk Hood, Rear Gate - Scratch - Minimal / (L) Front Door, Molding - Scratch &amp; Dent - Minimal / (L) Rear Fender, Molding - Scratch - Minimal / (L) Rear Door, Molding - Scratch - Minimal / (L) Mirror - Scratch - Minimal / (L) Front Fender, Molding - Scratch - Small / Front Bumper, Grille, Lamps - Scratch - Small / Bonnet, Headlight - Scratch - Small / Roof - Dent - Small / (R) Rear Fender, Molding - Scratch - Minimal</p> |
