## General Information

<b>Make</b>	Toyota	<b>Model</b>	Vios
<b>YOM</b>	2024	<b>Odo Meter Reading</b>	20,879
<b>Registration No.</b>	FAR5210	<b>Chassis No.</b>	PA1B18F34R4250597
<b>CC</b>	1.3	<b>Transmission</b>	CVT
<b>Fuel Type</b>	Gas	<b>Type of Body</b>	Sedan
<b>Colour</b>	Red Mica Metallic

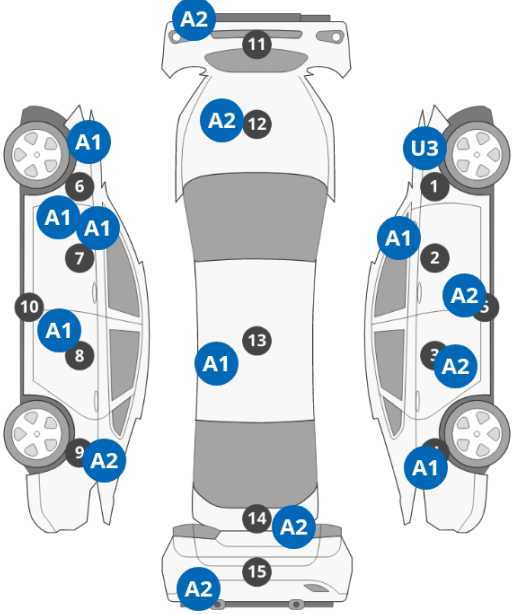
<p><b>A</b> : Scratch <b>AU</b> : Scratch &amp; Dent <b>B</b> : Modified <b>C</b> : Corrosion <b>G</b> : Stone chip <b>P</b> : Faded <b>S</b> : Rust <b>SC</b> : Rust &amp; Corrosion <b>U</b> : Dent <b>X</b> : Defective <b>Y</b> : Crack, Gap</p>
<p><b>Remarks</b> (L) Front Floor Mat - Worked - Small / (R) Front Trim - Grime - Small / (L) Front Trim - Grime - Small / Mat Other - Grime - Small / (R) Front Floor Mat - Grime - Small / Dashboard - Traces of Adhesive Tape - Yes</p>	<p><b>Remarks</b> (R) Front Fender, Molding - Dent - Medium / (R) Mirror - Scratch - Minimal / (R) Front Door, Molding - Scratch - Small / (R) Rear Door, Molding - Scratch - Small / (R) Rear Fender, Molding - Scratch - Minimal / Rear Bumper, Lamps, Panels - Scratch - Small / (L) Rear Fender, Molding - Scratch - Small / (L) Rear Door, Molding - Scratch - Minimal / (L) Front Door, Molding - Scratch - Minimal / (L) Mirror - Scratch - Minimal / (L) Front Fender, Molding - Scratch - Minimal / Bonnet, Headlight - Scratch - Small / Front Bumper, Grille, Lamps - Scratch - Small / Roof - Scratch - Minimal / Trunk Hood, Rear Gate - Scratch - Small</p>
