General Information

Make	Hino	Model	XZU600LA
YOM	2021	Odo Meter Reading	79,408
Registration No.	CAX5984	Chassis No.	PA4ACN4F2M9000405
CC	4.0	Transmission	A/T
Fuel Type	Diesel	Type of Body	Utility Vehicle
Colour	White

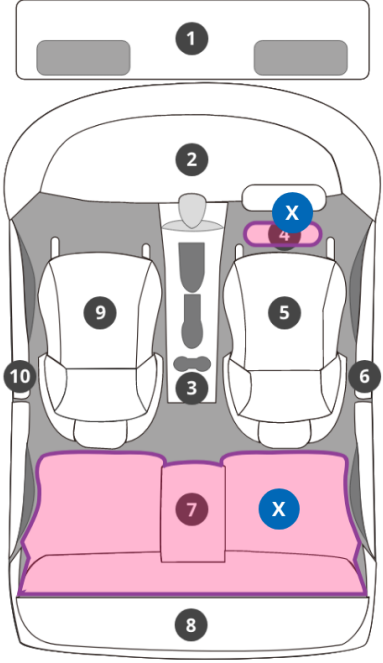
Interior Evaluation : B	Exterior Evaluation : C

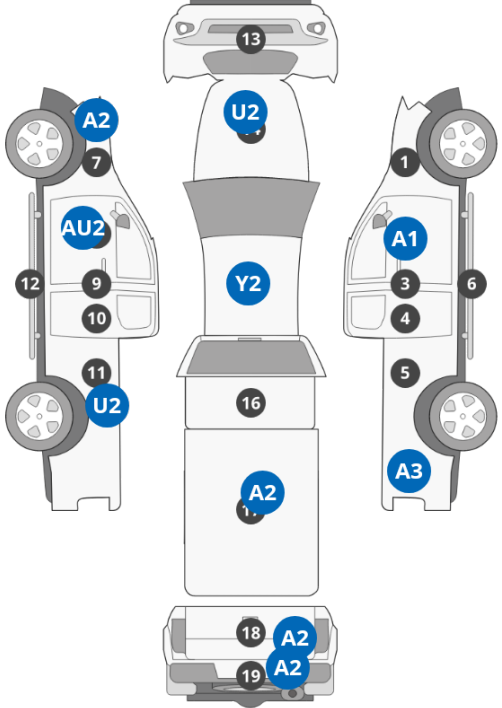
<p>A : Scratch AU : Scratch & Dent B : Modified C : Corrosion G : Stone chip P : Faded S : Rust SC : Rust & Corrosion U : Dent X : Defective Y : Crack, Gap</p>
Remarks Rear Seat - Missing - Yes / Mat Other - Missing - Yes	Remarks (R) Front Door - Repair Traces - Yes / Front Panel - Repair Traces - Yes / (L) Front Door - Repair Traces - Yes / (L) Rear Corner Panel - Repair Traces - Yes / (R) Rear Corner Panel - Repair Traces - Yes / Roof - Repair Traces - Yes / (L) Front Fender, Molding - Scratch - Small / Front Panel - Dent - Small / (L) Side Gate - Dent - Small / (L) Front Door, Molding - Scratch & Dent - Small / Front Windshield - Damaged - Small / (R) Side Gate - Scratch - Medium / Rear Gate - Scratch - Small / Rear Bumper, Lamps, Panels - Scratch - Small / Cab Back Panel - Scratch - Small / (R) Front Door, Molding - Scratch - Minimal
