Date & Time: 24, Sep, 2025 12:34

<b>Make</b>	Toyota	<b>Model</b>	Hilux
<b>YOM</b>	2024	<b>Odo Meter Reading</b>	62,112
<b>Registration No.</b>	EAG6828	<b>Chassis No.</b>	MR0JB8DD9P3221522
<b>CC</b>	2.4	<b>Transmission</b>	M/T
<b>Fuel Type</b>	Diesel	<b>Type of Body</b>	Pickup
<b>Colour</b>	Silver

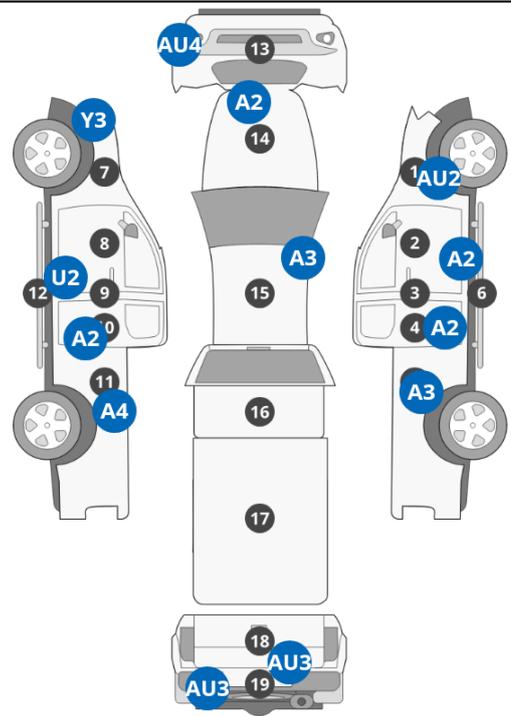
<p><b>A</b> : Scratch <b>AU</b> : Scratch &amp; Dent <b>B</b> : Modified <b>C</b> : Corrosion <b>G</b> : Stone chip <b>P</b> : Faded <b>S</b> : Rust <b>SC</b> : Rust &amp; Corrosion <b>U</b> : Dent <b>X</b> : Defective <b>Y</b> : Crack, Gap</p>
<p><b>Remarks</b> Rear Seat - Grime - Large / (R) Rear Trim - Grime - Medium / (L) Rear Trim - Grime - Medium / (R) Front Trim - Grime - Large / (L) Front Trim - Grime - Large / (R) Front Seat - Grime - Large / Console, Switchs, Vents - Worn, Scratch, Cut, Crack - Large / (L) Front Seat - Grime - Medium</p>	<p><b>Remarks</b> Front Bumper, Grille, Lamps - Scratch &amp; Dent - Large / (L) Front Fender, Molding - Crack, Gap - Medium / (L) Front Door, Molding - Dent - Small / (L) Rear Door, Molding - Scratch - Small / (L) Side Gate - Scratch - Large / Rear Bumper, Lamps, Panels - Scratch &amp; Dent - Medium / Rear Gate - Scratch &amp; Dent - Medium / (R) Side Gate - Scratch - Medium / (R) Rear Door, Molding - Scratch - Small / (R) Front Door, Molding - Scratch - Small / (R) Front Fender, Molding - Scratch &amp; Dent - Small / Roof - Scratch - Medium / Bonnet, Headlight - Scratch - Small</p>
