## General Information

<b>Make</b>	Toyota	<b>Model</b>	Vios
<b>YOM</b>	2024	<b>Odo Meter Reading</b>	41,517
<b>Registration No.</b>	NHQ3750	<b>Chassis No.</b>	PA1B18F38R4239845
<b>CC</b>	1.3	<b>Transmission</b>	CVT
<b>Fuel Type</b>	Gas	<b>Type of Body</b>	Sedan
<b>Colour</b>	Blue

## Body / Panel Condition

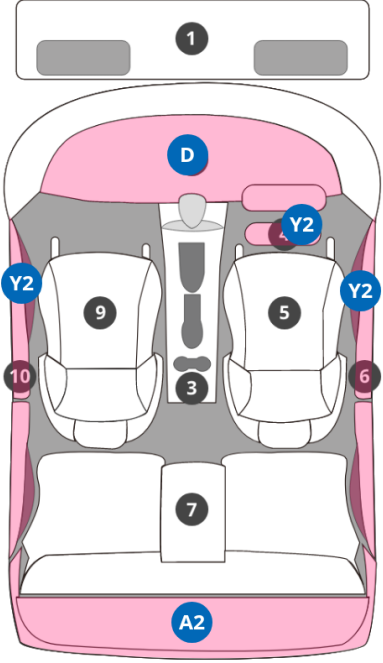
<p><b>A</b> : Scratch <b>AU</b> : Scratch &amp; Dent <b>B</b> : Modified <b>C</b> : Corrosion <b>G</b> : Stone chip <b>P</b> : Faded <b>S</b> : Rust <b>SC</b> : Rust &amp; Corrosion <b>U</b> : Dent <b>X</b> : Defective <b>Y</b> : Crack, Gap</p>
<p><b>Remarks</b> (R) Front Trim - Grime - Small / (L) Front Floor Mat - Grime - Small / Dashboard - Traces of Adhesive Tape - Yes / (L) Front Trim - Grime - Small / Trunk Room - Worn, Scratch, Cut, Crack - Small</p>	<p><b>Remarks</b> Bonnet - Repair Traces - Yes / Front Bumper, Grille, Lamps - Dent - Small / (R) Front Fender, Molding - Scratch - Minimal / (R) Front Door, Molding - Scratch - Minimal / (R) Rear Fender, Molding - Crack, Gap - Small / Trunk Hood, Rear Gate - Scratch - Minimal / (L) Front Fender, Molding - Crack, Gap - Small / (L) Front Door, Molding - Scratch - Minimal / (L) Rear Fender, Molding - Scratch - Minimal / Rear Bumper, Lamps, Panels - Scratch - Minimal / Bonnet, Headlight - Scratch - Minimal / Bonnet, Headlight - Repair mark - Yes</p>
